## Utility Conflict Report

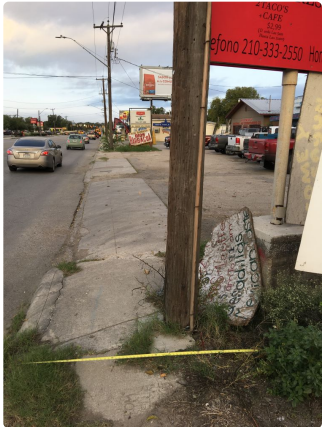
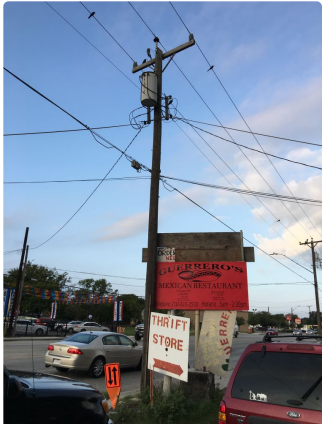
<b>OWNER</b>	<b>Utility</b>	CPS	<b>Corridor</b>	RIGSBY	<b>SITE PHOTOS</b>	
	<b>Contact</b>	JAKE MARTINEZ	<b>ID</b>	2069		
<b>GENERAL INFO</b>	<b>Utility</b>	ELECTRIC				
	<b>Size and Material</b>	STANDARD POWER POLE, TIMBER				
	<b>Utility Conflict Description</b>	POLE WITHIN PROPOSED SIDEWALK				
	<b>Longitudinal or Crossing</b>	CROSSING				
	<b>Placement Relative to ROW</b>	INSIDE				
<b>LOCATION</b>	<b>Sheet No.</b>	325				
	<b>Station Origin</b>					
	<b>Start Station</b>	655+42.17	<b>End Station</b>			
	<b>Start Offset</b>	9.45	<b>End Offset</b>			
	<b>Latitude</b>	29.398164219	<b>Longitude</b>	-98.434128236999996		
<b>SUE</b>	<b>Level of Investigation Req'd</b>	NONE				
	<b>Test Hole No</b>	N/A				
	<b>Test Hole Depth</b>	N/A				
<b>RESOLUTION</b>	<b>Recommended Action</b>	ACCOMMODATE - RELOCATION				
	<b>Estimated Resolution Date</b>					
	<b>Resolution Status</b>	UTILITY COORDINATION IN PROGRESS

<b>Comment</b>	INSUFFICIENT CLEARANCE PER PROWAG, 48" CLEARANCE REQUIRED. 41" BACK OF CURB TO FACE OF POLE, 11" POLE DIA, 21" BACK OF POLE TO ROW (BACK OF SIDEWALK)				
<b>Date Collected</b>		8/14/2017 11:03:44 AM		<b>Date Modified</b> 11/27/2017 10:45:19 AM
