Utility Conflict Report

| OWNER | Utility | CPS | Corridor | RIGSBY | SITE PHOTOS | |
| GENERAL INFO | Utility | ELECTRIC | | | | |

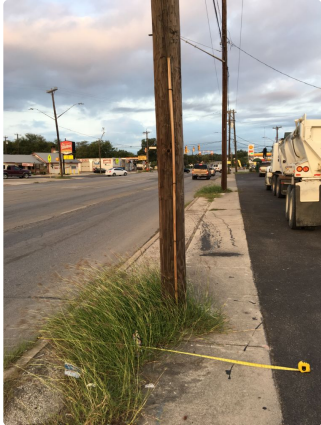
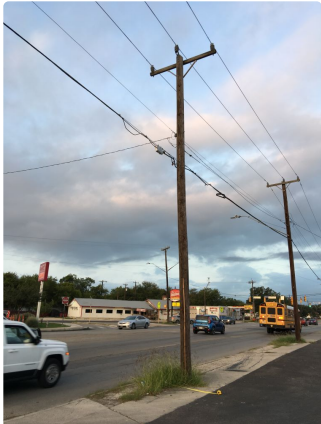
| | Utility Conflict Description | POLE WITHIN PROPOSED SIDEWALK | | | | |
| | Comment | INSUFFICIENT CLEARANCE PER PROWAG, 48" CLEARANCE REQUIRED. 40" BACK OF CURB TO FACE OF POLE, 12" POLE DIA, 32" BACK OF POLE TO ROW (BACK OF SIDEWALK) | | | | |

| RESOLUTION | Recommended Action | ACCOMMODATE - RELOCATION | | | | |
