## Utility Conflict Report

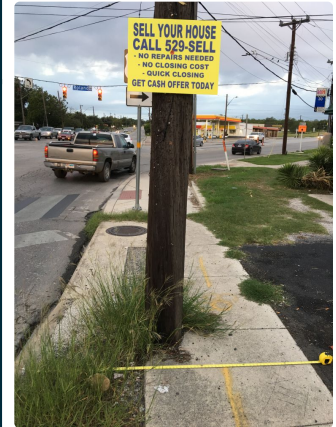
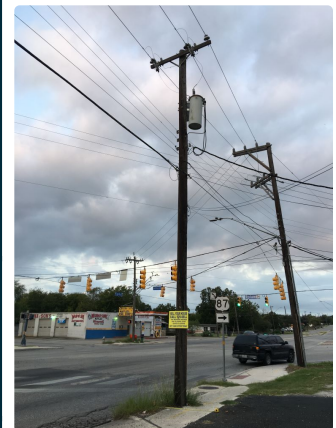
<b>OWNER</b>	<b>Utility</b>	CPS	<b>Corridor</b>	RIGSBY	<b>SITE PHOTOS</b>
	<b>Contact</b>	JAKE MARTINEZ	<b>ID</b>	238	
<b>GENERAL INFO</b>	<b>Utility</b>	ELECTRIC			
	<b>Size and Material</b>	STANDARD POWER POLE, TIMBER			
	<b>Utility Conflict Description</b>	POLE WITHIN PROPOSED SIDEWALK			
	<b>Longitudinal or Crossing</b>	CROSSING			
	<b>Placement Relative to ROW</b>	INSIDE			
<b>LOCATION</b>	<b>Sheet No.</b>	328			
	<b>Station Origin</b>				
	<b>Start Station</b>	662+03.92	<b>End Station</b>		
	<b>Start Offset</b>	9.54	<b>End Offset</b>		
	<b>Latitude</b>	29.398172594	<b>Longitude</b>	-98.436206193000004	
<b>SUE</b>	<b>Level of Investigation Req'd</b>	NONE			
	<b>Test Hole No</b>	N/A			
	<b>Test Hole Depth</b>	N/A			
<b>RESOLUTION</b>	<b>Recommended Action</b>	ACCOMODATE - RELOCATION			
	<b>Estimated Resolution Date</b>				
	<b>Resolution Status</b>	UTILITY COORDINATION IN PROGRESS			
	<b>Comment</b>	INSUFFICIENT CLEARANCE PER PROWAG, 48" CLEARANCE REQUIRED. 31" BACK OF CURB TO FACE OF POLE, 14" POLE DIA, 35" BACK OF POLE TO ROW (BACK OF SIDEWALK)
