Utility Conflict Report

| OWNER | Utility | CPS | Corridor | BANDERA | SITE PHOTOS |
| | Contact | JAKE MARTINEZ | ID | 3189 | |

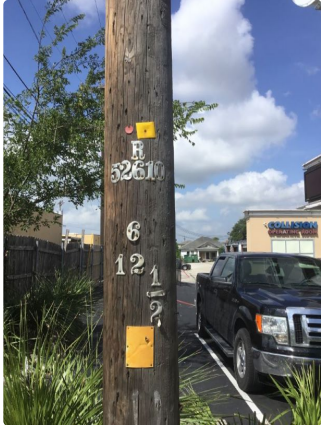
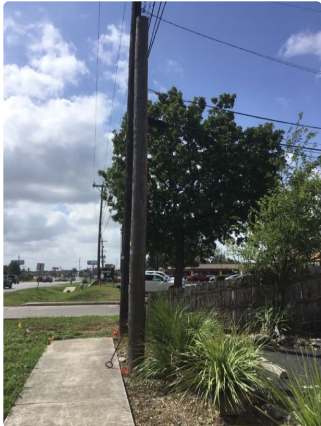
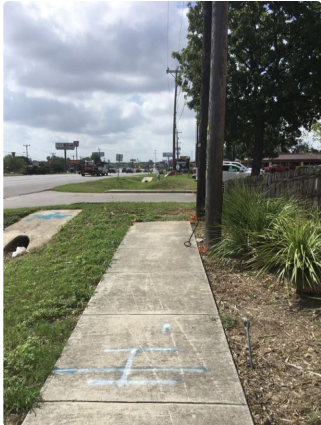
| | Size and Material | STANDARD POWER POLE, TIMBER | | | |
| RESOLUTION | Recommended Action | NO CONFLICT | | | |
| | Comment | Pole diameter = 12" | | | |
| | | Back of sidewalk to pole = 4" Underground cable warning on pole No overhead lines attached to pole | | | |
