Utility Conflict Report

| OWNER | Utility | CPS | Corridor | BANDERA | SITE PHOTOS | | |
| | Contact | BILL FEY | ID | 3217 | | | |

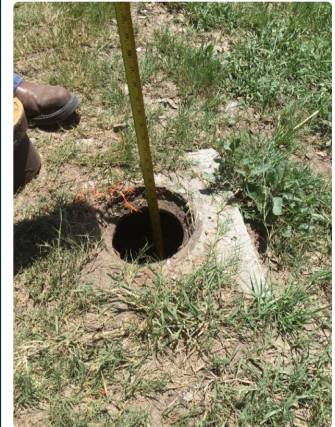
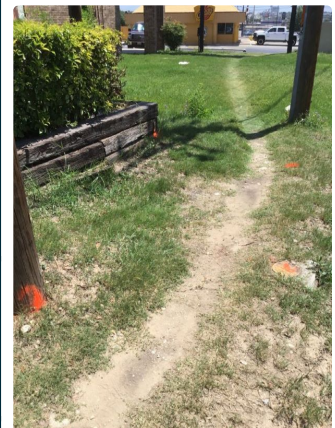
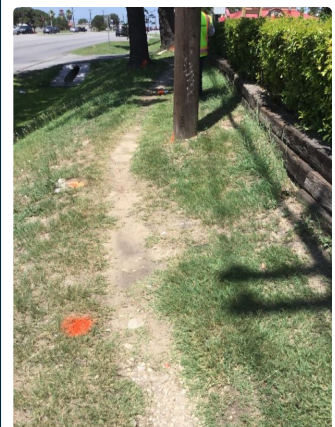
| | Size and Material | STANDARD GAS VALVE, CAST IRON | | | | | |
| RESOLUTION | Recommended Action | NO CONFLICT | | | | | |
| | Comment | Top of valve to surface = 2'-10" Lid thickness = 1 1/2" Face of wall to valve = 6'-9" | | | | | |
