Utility Conflict Report

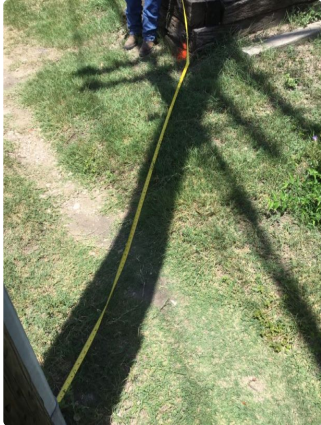
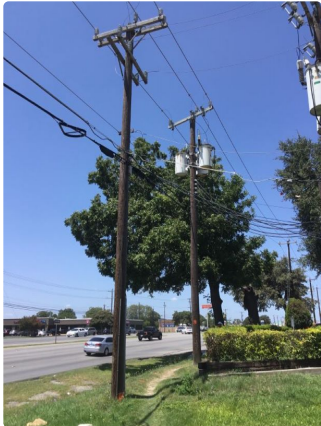
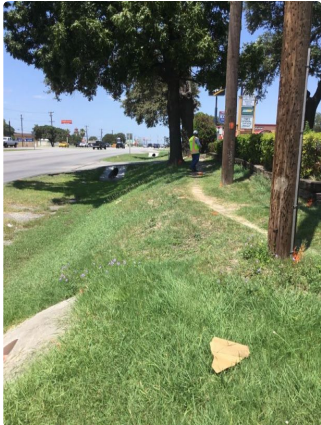
OWNER	Utility	CPS	Corridor	BANDERA	SITE PHOTOS		
	Contact	JAKE MARTINEZ	ID	3218			
GENERAL INFO	Utility	ELECTRIC					
	Size and Material	STANDARD POWER POLE, TIMBER					
	Accessible Route	ASSET IS OUTSIDE ACCESSIBLE ROUTE					
	Longitudinal or Crossing	CROSSING					
	Placement Relative to ROW	INSIDE ROW					
LOCATION	Sheet No.						
	Station						
	Offset						
	Latitude	+29.500554					
	Longitude	-98.62453					
SUE	Level of Investigation Req'd	NONE					
	Test Hole No	N/A					
	Test Hole Depth	N/A					
RESOLUTION	Recommended Action	NO CONFLICT					
	Estimated Resolution Date	8/28/2018					
	Resolution Status	NO RESOLUTION WAS REQUIRED					
	Comment	Corner of wall to pole = 8'-10" No pole ID Back of culvert concrete safety end treatment to pole = 7'-4"					
Date Collected		8/17/2018 1:36:23 PM		Date Modified		11/28/2018 6:59:12 AM
