Utility Conflict Report

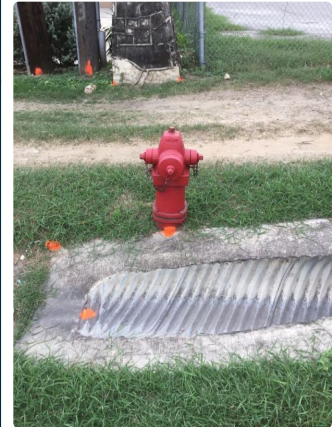
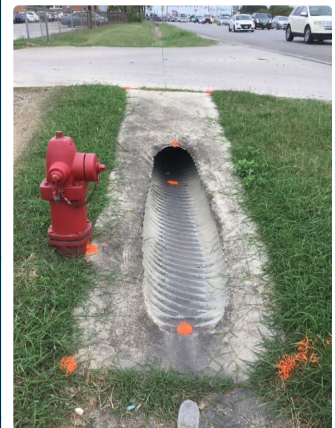
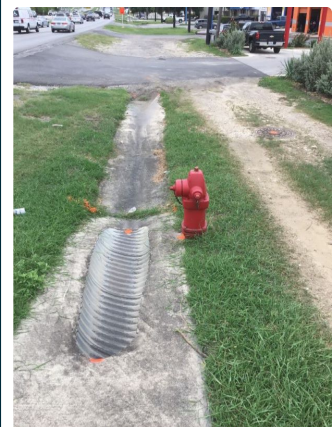
OWNER	Utility	SAWS	Corridor	BANDERA	SITE PHOTOS
	Contact	ANN PECHE	ID	3234	
GENERAL INFO	Utility	WATER			
	Size and Material	STANDARD FIRE HYDRANT			
	Accessible Route	ASSET IS OUTSIDE ACCESSIBLE ROUTE			
	Longitudinal or Crossing	CROSSING			
	Placement Relative to ROW	INSIDE ROW			
LOCATION	Sheet No.				
	Station				
	Offset				
	Latitude	+29.493901			
	Longitude	-98.61725			
SUE	Level of Investigation Req'd	NONE			
	Test Hole No	N/A			
	Test Hole Depth	N/A			
RESOLUTION	Recommended Action	NO CONFLICT			
	Estimated Resolution Date	8/28/2018			
	Resolution Status	NO RESOLUTION WAS REQUIRED			
	Comment	Hydrant adjacent to culvert concrete safety end treatment			
Date Collected		8/20/2018 9:21:22 AM	Date Modified		11/28/2018 6:59:12 AM
