Utility Conflict Report

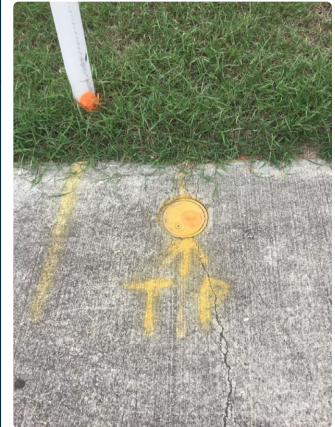
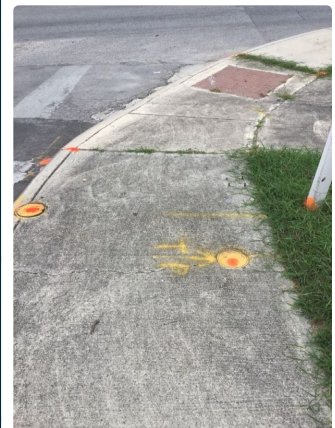
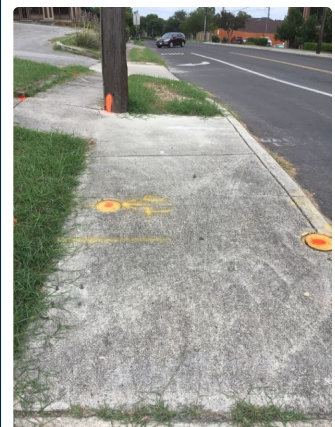
OWNER	Utility	CPS	Corridor	BANDERA	SITE PHOTOS
	Contact	BILL FEY	ID	3250	
GENERAL INFO	Utility	GAS			
	Size and Material	STANDARD GAS VALVE, CAST IRON			
	Accessible Route	ASSET IS INSIDE ACCESSIBLE ROUTE			
	Longitudinal or Crossing	CROSSING			
	Placement Relative to ROW	INSIDE ROW			
LOCATION	Sheet No.	234			
	Station	1753+61.21			
	Offset	-40.15			
	Latitude	+29.490905			
	Longitude	-98.61305			
SUE	Level of Investigation Req'd	NONE			
	Test Hole No	N/A			
	Test Hole Depth	N/A			
RESOLUTION	Recommended Action	MINIMIZE - PROTECT IN PLACE			
	Estimated Resolution Date				
	Resolution Status	UTILITY OWNER INFORMED OF UTILITY			
	Comment	Unable to open lid Back of sidewalk to valve = 9"			
Date Collected		8/20/2018 10:42:48 AM	Date Modified		12/19/2018 11:48:23 AM
