# Utility Conflict Report

<b>OWNER</b>	<b>Utility</b>	SAWS	<b>Corridor</b>	SW MILITARY	<b>SITE PHOTOS</b>		
	<b>Contact</b>	ANN PECHE	<b>ID</b>	4129			
<b>GENERAL INFO</b>	<b>Utility</b>	WATER

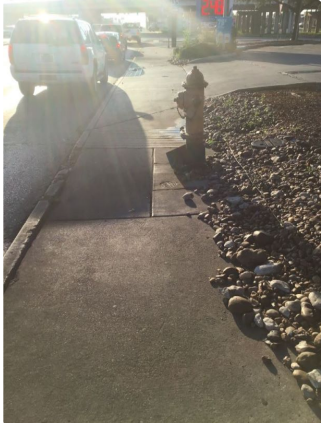
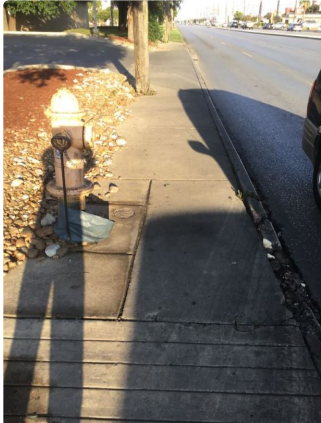
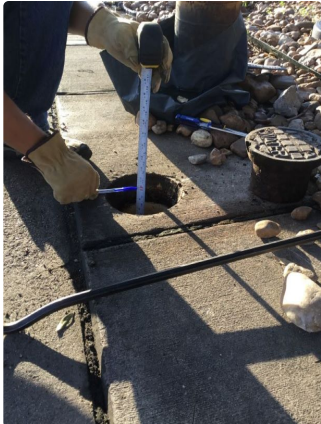
<b>Size and Material</b>	STANDARD WATER VALVE, CAST IRON					
	<b>Accessible Route</b>	ASSET IS INSIDE ACCESSIBLE ROUTE					
	<b>Longitudinal or Crossing</b>	CROSSING					
	<b>Placement Relative to ROW</b>	INSIDE ROW					
<b>LOCATION</b>	<b>Sheet No.</b>	148

<b>Test Hole No</b>	N/A					
	<b>Test Hole Depth</b>	N/A					
<b>RESOLUTION</b>	<b>Recommended Action</b>	MINIMIZE - PROTECT IN PLACE					
	<b>Estimated Resolution Date</b>						
	<b>Resolution Status</b>	UTILITY OWNER INFORMED OF UTILITY					
	<b>Comment</b>	Valve to back of curb = 3'-6" Valve to back of sidewalk = 2'-7" Sidewalk width = 6'-8" Top of valve to surface = 1'-0" Lid thickness = 1 1/2"
