## Utility Conflict Report

<b>OWNER</b>	<b>Utility</b>	SAWS	<b>Corridor</b>	SW MILITARY	<b>SITE PHOTOS</b>	
	<b>Contact</b>	ANN PECHE	<b>ID</b>	4172		
<b>GENERAL INFO</b>	<b>Utility</b>	WATER

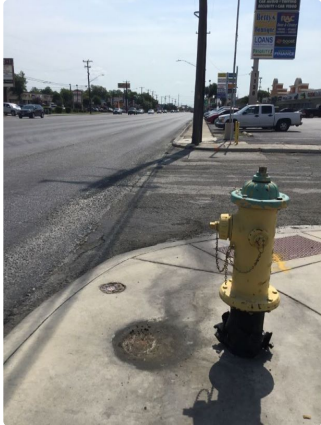
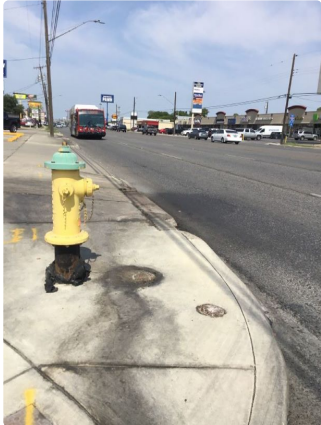
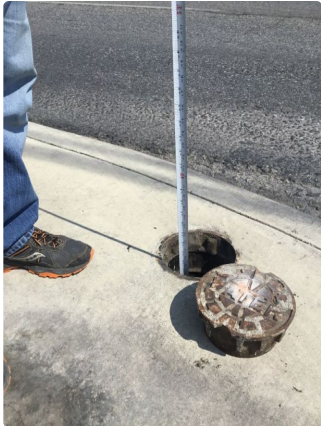
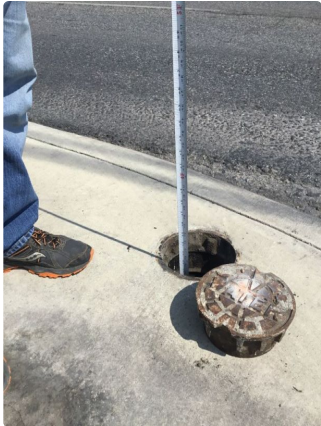
<b>Size and Material</b>	STANDARD WATER VALVE, CAST IRON				
	<b>Accessible Route</b>	ASSET IS INSIDE ACCESSIBLE ROUTE				
	<b>Longitudinal or Crossing</b>	CROSSING				
	<b>Placement Relative to ROW</b>	INSIDE ROW				
<b>LOCATION</b>	<b>Sheet No.</b>	158

<b>Estimated Resolution Date</b>					
	<b>Resolution Status</b>	NO RESOLUTION WAS REQUIRED				
	<b>Comment</b>	Back of curb to valve = 5" Face of wall to valve = 6'-8" Sidewalk width = 7'-10" Top of valve to surface = 3'-1/2" Lid flange thickness = 2" Total lid thickness = 3 1/2"

<b>Test Hole No</b>	N/A				
	<b>Test Hole Depth</b>	N/A				
<b>RESOLUTION</b>	<b>Recommended Action</b>	NO CONFLICT
