Utility Conflict Report

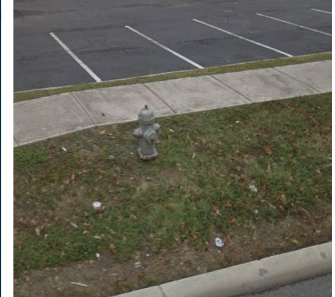
OWNER	Utility	SAWS	Corridor	BANDERA	SITE PHOTOS
	Contact	ANN PECHE	ID	4615	
GENERAL INFO	Utility	WATER			
	Size and Material	STANDARD WATER VALVE, CAST IRON			
	Accessible Route	ASSET IS INSIDE ACCESSIBLE ROUTE			
	Longitudinal or Crossing	CROSSING			
	Placement Relative to ROW	INSIDE ROW			
LOCATION	Sheet No.	338			
	Station	2026+86.40			
	Offset	-19.89			
	Latitude	+29.484870			
	Longitude	-98.594916			
SUE	Level of Investigation Req'd	NONE			
	Test Hole No	N/A			
	Test Hole Depth	N/A			
RESOLUTION	Recommended Action	MINIMIZE - PROTECT IN PLACE			
	Estimated Resolution Date				
	Resolution Status	UTILITY OWNER INFORMED OF UTILITY			
	Comment				
Date Collected		12/18/2018 2:37:50 PM	Date Modified		12/19/2018 11:48:35 AM
