Utility Conflict Report

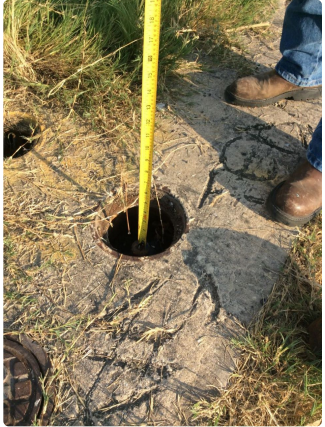
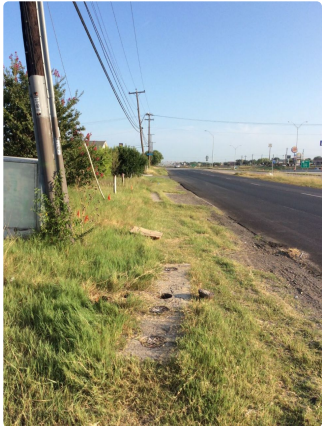
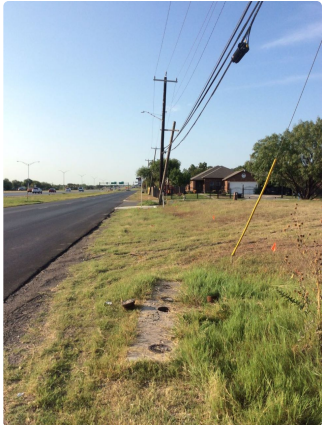
OWNER	Utility	CPS	Corridor	SW LOOP 410	SITE PHOTOS		
	Contact	JAKE MARTINEZ	ID	7002			
GENERAL INFO	Utility	GAS					
	Size and Material	STANDARD GAS VALVE, CAST IRON					
	Accessible Route	ASSET IS INSIDE ACCESSIBLE ROUTE					
	Longitudinal or Crossing	CROSSING					
	Placement Relative to ROW	INSIDE ROW					
LOCATION	Sheet No.						
	Station	295+81.28					
	Offset	-18.6223					
	Latitude	+29.377260					
	Longitude	-98.64031					
SUE	Level of Investigation Req'd	NONE					
	Test Hole No	N/A					
	Test Hole Depth	N/A					
RESOLUTION	Recommended Action	NO CONFLICT					
	Estimated Resolution Date	8/13/2018					
	Resolution Status	NO RESOLUTION WAS REQUIRED					
	Comment	2 gas valves in concrete riprap (3 and 4 of 4) Top of valves to surface = 0" Edge of pavement to front edge of riprap = 6'-3"					
Date Collected		8/2/2018 8:28:06 AM		Date Modified		8/14/2018 4:38:26 PM
