## Utility Conflict Report

<b>OWNER</b>	<b>Utility</b>	SAWS	<b>Corridor</b>	SW MILITARY	<b>SITE PHOTOS</b>		
	<b>Contact</b>	ANN PECHE	<b>ID</b>	7025			
<b>GENERAL INFO</b>	<b>Utility</b>	WATER

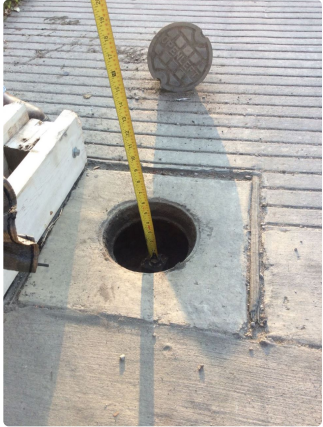
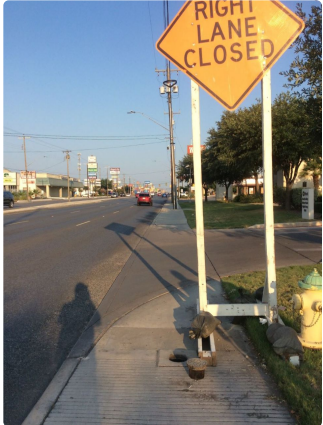
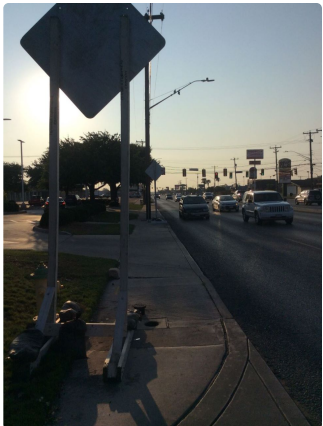
<b>Size and Material</b>	STANDARD WATER VALVE, CAST IRON					
	<b>Accessible Route</b>	ASSET IS INSIDE ACCESSIBLE ROUTE					
	<b>Longitudinal or Crossing</b>	CROSSING					
	<b>Placement Relative to ROW</b>	INSIDE ROW					
<b>LOCATION</b>	<b>Sheet No.</b>	213

<b>Test Hole No</b>	N/A					
	<b>Test Hole Depth</b>	N/A					
<b>RESOLUTION</b>	<b>Recommended Action</b>	MINIMIZE - PROTECT IN PLACE					
	<b>Estimated Resolution Date</b>						
	<b>Resolution Status</b>	UTILITY OWNER INFORMED OF UTILITY					
	<b>Comment</b>	Top of valve to bottom of lid = 3 1/2" Lid thickness = 1 1/2" Back of curb to valve = 2'-10"
