## Utility Conflict Report

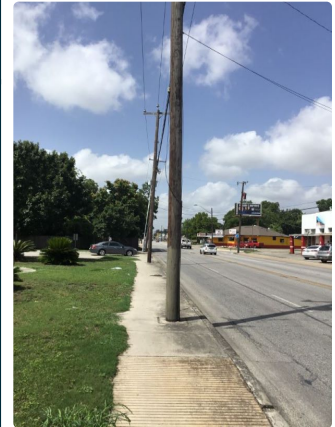
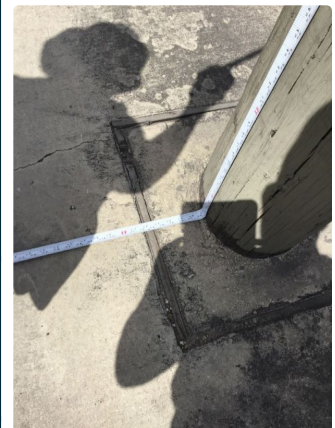
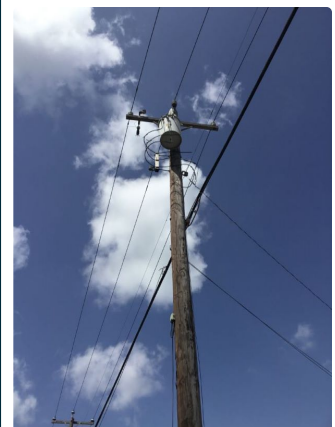
<b>OWNER</b>	<b>Utility</b>	CHARTER	<b>Corridor</b>	NOGALITOS	<b>SITE PHOTOS</b>
	<b>Contact</b>	FRANK CYPRIAN	<b>ID</b>	1017	
<b>GENERAL INFO</b>	<b>Utility</b>	COMMUNICATIONS			
	<b>Size and Material</b>	OVERHEAD TELECOMM LINES			
	<b>Accessible Route</b>	ASSET IS INSIDE ACCESSIBLE ROUTE			
	<b>Longitudinal or Crossing</b>	LONGITUDINAL			
	<b>Placement Relative to ROW</b>	INSIDE ROW			
<b>LOCATION</b>	<b>Sheet No.</b>	83			
	<b>Station</b>	131+16.31			
	<b>Offset</b>	22.81			
	<b>Latitude</b>	+29.392916			
	<b>Longitude</b>	-98.51832			
<b>SUE</b>	<b>Level of Investigation Req'd</b>	NONE			
	<b>Test Hole No</b>	N/A			
	<b>Test Hole Depth</b>	N/A			
<b>RESOLUTION</b>	<b>Recommended Action</b>	MINIMIZE - PROTECT IN PLACE			
	<b>Estimated Resolution Date</b>				
	<b>Resolution Status</b>	UTILITY OWNER INFORMED OF UTILITY			
	<b>Comment</b>	Related to utility ID 4066			
<b>Date Collected</b>		<b>Date Modified</b>		9/13/2018 2:02:11 PM
