## Utility Conflict Report

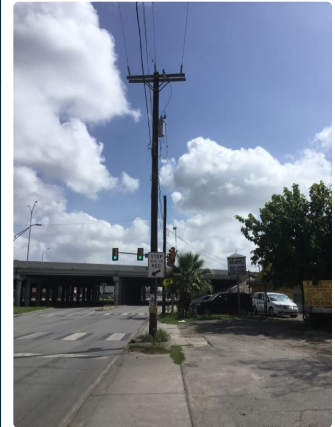
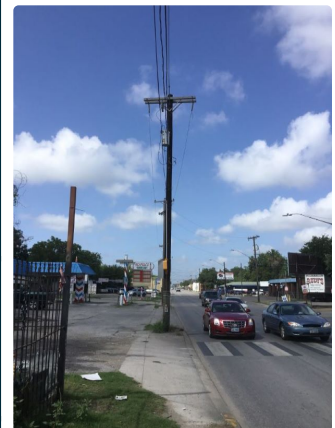
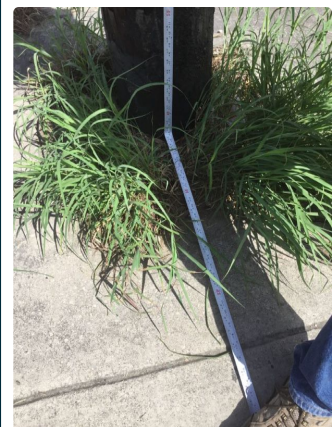
<b>OWNER</b>	<b>Utility</b>	CHARTER	<b>Corridor</b>	NOGALITOS	<b>SITE PHOTOS</b>
	<b>Contact</b>	FRANK CYPRIAN	<b>ID</b>	1177	
<b>GENERAL INFO</b>	<b>Utility</b>	COMMUNICATIONS			
	<b>Size and Material</b>	OVERHEAD TELECOMM LINES			
	<b>Accessible Route</b>	ASSET IS INSIDE ACCESSIBLE ROUTE			
	<b>Longitudinal or Crossing</b>	LONGITUDINAL			
	<b>Placement Relative to ROW</b>	INSIDE ROW			
<b>LOCATION</b>	<b>Sheet No.</b>	90			
	<b>Station</b>	143+18.49			
	<b>Offset</b>	19.85			
	<b>Latitude</b>	+29.395656			
	<b>Longitude</b>	-98.51587			
<b>SUE</b>	<b>Level of Investigation Req'd</b>	NONE			
	<b>Test Hole No</b>	N/A			
	<b>Test Hole Depth</b>	N/A			
<b>RESOLUTION</b>	<b>Recommended Action</b>	MINIMIZE - PROTECT IN PLACE			
	<b>Estimated Resolution Date</b>				
	<b>Resolution Status</b>	UTILITY OWNER INFORMED OF UTILITY			
	<b>Comment</b>	Related to utility ID: 3062			
<b>Date Collected</b>		<b>Date Modified</b>		9/13/2018 2:03:28 PM
