## Utility Conflict Report

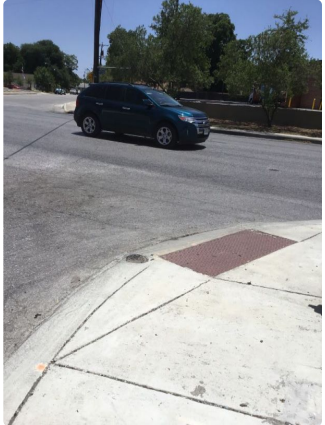
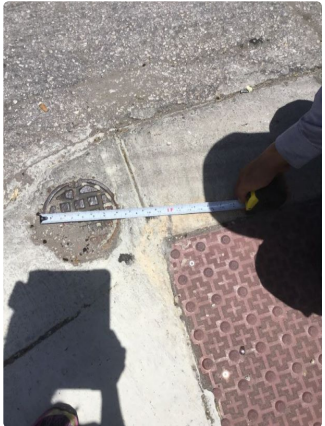
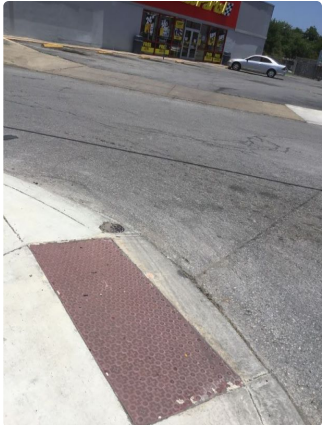
<b>OWNER</b>	<b>Utility</b>	SAWS	<b>Corridor</b>	NOGALITOS	<b>SITE PHOTOS</b>
	<b>Contact</b>	NINA BITTLE	<b>ID</b>	3010	
<b>GENERAL INFO</b>	<b>Utility</b>	WATER			
	<b>Size and Material</b>	STANDARD WATER VALVE, CAST IRON			
	<b>Accessible Route</b>	ASSET IS OUTSIDE ACCESSIBLE ROUTE			
	<b>Longitudinal or Crossing</b>	CROSSING			
	<b>Placement Relative to ROW</b>	INSIDE ROW			
<b>LOCATION</b>	<b>Sheet No.</b>				
	<b>Station</b>	111+35.17			
	<b>Offset</b>	-32.7126			
	<b>Latitude</b>	+29.388693			
	<b>Longitude</b>	-98.52211			
<b>SUE</b>	<b>Level of Investigation Req'd</b>	NONE			
	<b>Test Hole No</b>	N/A			
	<b>Test Hole Depth</b>	N/A			
<b>RESOLUTION</b>	<b>Recommended Action</b>	NO CONFLICT			
	<b>Estimated Resolution Date</b>	8/13/2018			
	<b>Resolution Status</b>	NO RESOLUTION WAS REQUIRED			
	<b>Comment</b>	Unable to open lid			
<b>Date Collected</b>		7/2/2018 1:35:03 PM		<b>Date Modified</b> 8/14/2018 4:38:26 PM
