Utility Conflict Report

OWNER	Utility	SAWS	Corridor	NOGALITOS	SITE PHOTOS
	Contact	ANN PECHE	ID	3052	
GENERAL INFO	Utility	WATER

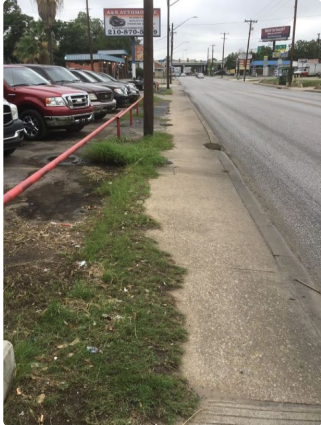
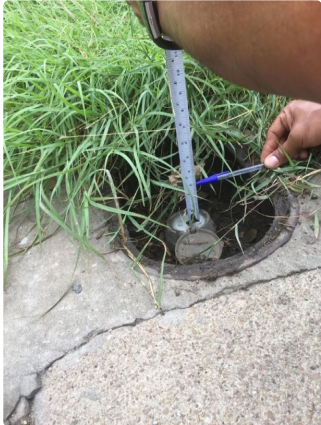
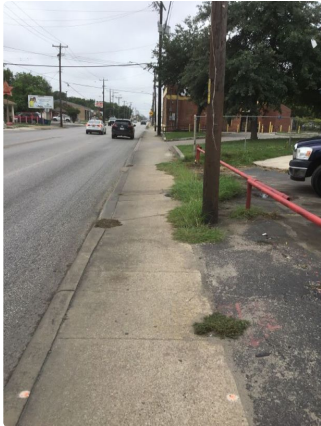
Size and Material	STANDARD WATER METER, STEEL			
	Accessible Route	ASSET IS INSIDE ACCESSIBLE ROUTE			
	Longitudinal or Crossing	CROSSING			
	Placement Relative to ROW	INSIDE ROW			
LOCATION	Sheet No.	128

Comment	Top of meter to surface = 3" Oval rubber lid thickness = 2" Meter to back of curb = 3'-4" Sidewalk width = 5'-5" Lower underlying asset, not enough vertical clearance inside meter box to lower 4-5" needed			
Date Collected		7/11/2018 8:44:36 AM	Date Modified		10/12/2018 3:14:06 PM

Test Hole No	N/A			
	Test Hole Depth	N/A			
RESOLUTION	Recommended Action	MINIMIZE - PROTECT IN PLACE			
	Estimated Resolution Date				
	Resolution Status	UTILITY OWNER INFORMED OF UTILITY
