## Utility Conflict Report

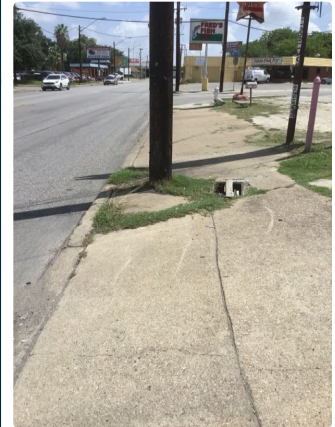
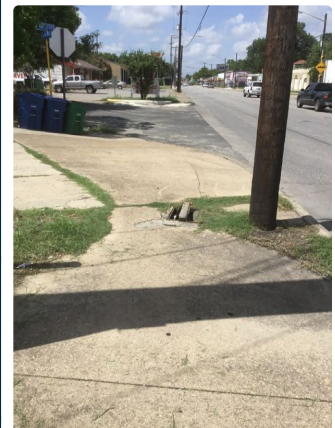
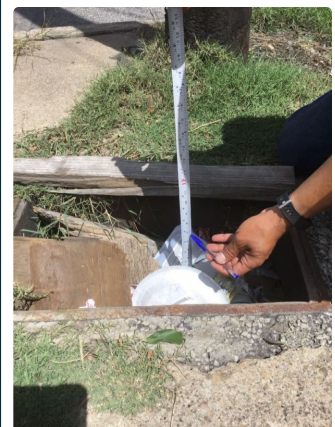
<b>OWNER</b>	<b>Utility</b>	SAWS	<b>Corridor</b>	NOGALITOS	<b>SITE PHOTOS</b>		
	<b>Contact</b>	ANN PECHE	<b>ID</b>	3066			
<b>GENERAL INFO</b>	<b>Utility</b>	WATER					
	<b>Size and Material</b>	STANDARD WATER VALVE, CAST IRON					
	<b>Accessible Route</b>	ASSET IS INSIDE ACCESSIBLE ROUTE					
	<b>Longitudinal or Crossing</b>	CROSSING					
	<b>Placement Relative to ROW</b>	INSIDE ROW					
<b>LOCATION</b>	<b>Sheet No.</b>	86					
	<b>Station</b>	136+43.20					
	<b>Offset</b>	25.5205					
	<b>Latitude</b>	+29.394001					
	<b>Longitude</b>	-98.51718					
<b>SUE</b>	<b>Level of Investigation Req'd</b>	NONE					
	<b>Test Hole No</b>	N/A					
	<b>Test Hole Depth</b>	N/A					
<b>RESOLUTION</b>	<b>Recommended Action</b>	NO CONFLICT					
	<b>Estimated Resolution Date</b>						
	<b>Resolution Status</b>	NO RESOLUTION WAS REQUIRED					
	<b>Comment</b>	Top of valve to surface = 6 1/2" Box to back of sidewalk = approx. 2'-6" Box to back of curb = 4'-2" Sidewalk width = 8'-2" No lid Replace meter box only
