Utility Conflict Report

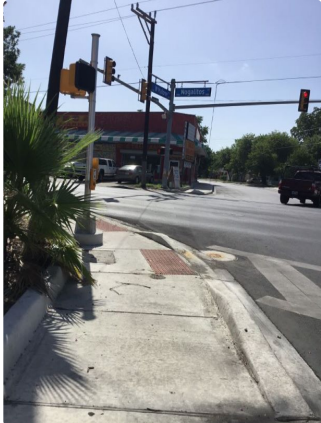
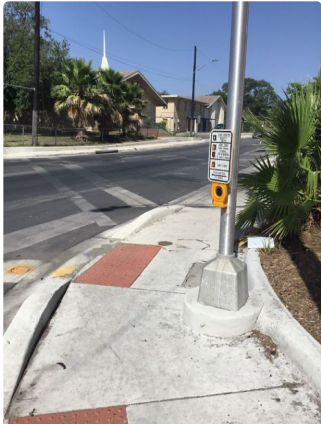
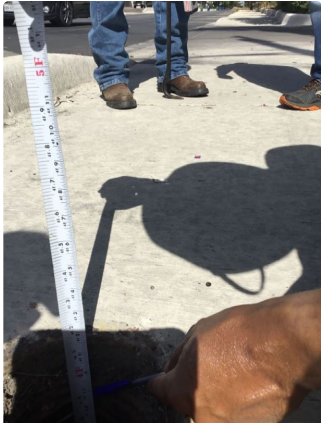
OWNER	Utility	CPS	Corridor	NOGALITOS	SITE PHOTOS
	Contact	JAKE MARTINEZ	ID	4010	
GENERAL INFO	Utility	GAS			
	Size and Material	STANDARD GAS VALVE, CAST IRON			
	Accessible Route	ASSET IS INSIDE ACCESSIBLE ROUTE			
	Longitudinal or Crossing	CROSSING			
	Placement Relative to ROW	INSIDE ROW			
LOCATION	Sheet No.				
	Station	104+75.60			
	Offset	-34.7585			
	Latitude	+29.387202			
	Longitude	-98.52335			
SUE	Level of Investigation Req'd	NONE			
	Test Hole No	N/A			
	Test Hole Depth	N/A			
RESOLUTION	Recommended Action	NO CONFLICT			
	Estimated Resolution Date	8/13/2018			
	Resolution Status	NO RESOLUTION WAS REQUIRED			
	Comment	Top of valve is 3'-9" below the surface Lid thickness = 1 1/2" Back of curb to valve = 1'-8 1/2"			
Date Collected 7/2/2018 10:16:47 AM Date Modified 8/14/2018 4:38:26 PM
