## Utility Conflict Report

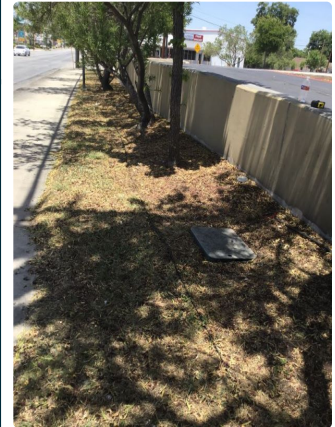
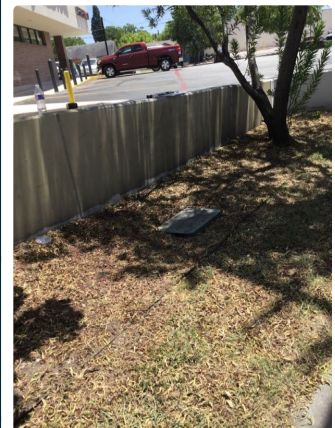
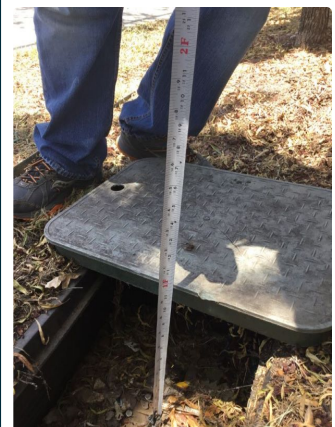
<b>OWNER</b>	<b>Utility</b>	SAWS	<b>Corridor</b>	NOGALITOS	<b>SITE PHOTOS</b>		
	<b>Contact</b>	NINA BITTLE	<b>ID</b>	4028			
<b>GENERAL INFO</b>	<b>Utility</b>	WATER					
	<b>Size and Material</b>	STANDARD WATER METER, STEEL					
	<b>Accessible Route</b>	ASSET IS OUTSIDE ACCESSIBLE ROUTE					
	<b>Longitudinal or Crossing</b>	CROSSING					
	<b>Placement Relative to ROW</b>	INSIDE ROW					
<b>LOCATION</b>	<b>Sheet No.</b>						
	<b>Station</b>	110+71.96					
	<b>Offset</b>	31.7388					
	<b>Latitude</b>	+29.388416					
	<b>Longitude</b>	-98.52214					
<b>SUE</b>	<b>Level of Investigation Req'd</b>	NONE					
	<b>Test Hole No</b>	N/A					
	<b>Test Hole Depth</b>	N/A					
<b>RESOLUTION</b>	<b>Recommended Action</b>	NO CONFLICT					
	<b>Estimated Resolution Date</b>	8/13/2018					
	<b>Resolution Status</b>	NO RESOLUTION WAS REQUIRED					
	<b>Comment</b>	Meter to face of retaining wall = 1'-8"					
<b>Date Collected</b>		7/2/2018 2:25:21 PM		<b>Date Modified</b>		8/14/2018 4:38:26 PM
