Utility Conflict Report

OWNER	Utility	SAWS	Corridor	NOGALITOS	SITE PHOTOS	
	Contact	NINA BITTLE	ID	4034		
GENERAL INFO	Utility	WATER

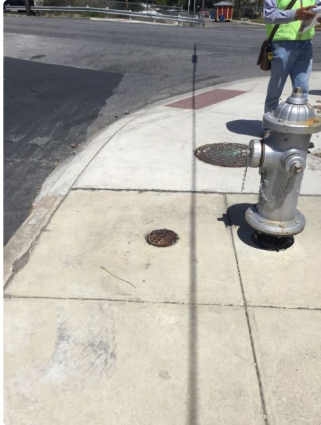
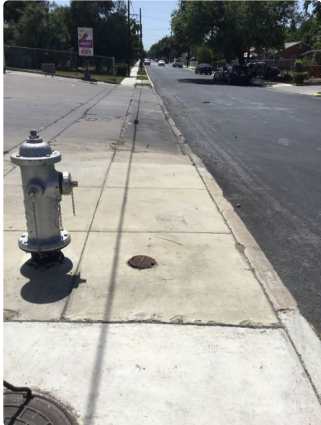
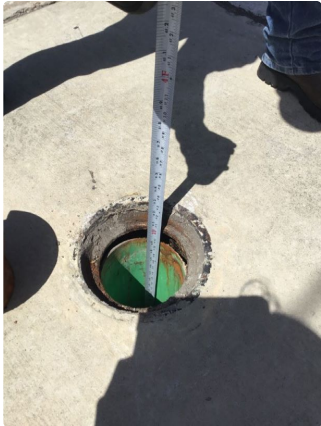
Size and Material	STANDARD WATER VALVE, CAST IRON				
	Accessible Route	ASSET IS INSIDE ACCESSIBLE ROUTE				
	Longitudinal or Crossing	CROSSING				
	Placement Relative to ROW	INSIDE ROW				
LOCATION	Sheet No.

Test Hole No	N/A				
	Test Hole Depth	N/A				
RESOLUTION	Recommended Action	NO CONFLICT				
	Estimated Resolution Date	8/13/2018				
	Resolution Status	NO RESOLUTION WAS REQUIRED				
	Comment	Top of valve to surface = 3'-0" Lid thickness = 1.5" Back of curb to valve = 2'-4"				
Date Collected		7/2/2018 3:31:55 PM		Date Modified	8/14/2018 4:38:26 PM
