**CIVIC/CONVENTION CENTER
375 South Castell Avenue
New Braunfels, TX 78130**

ADA SELF-EVALUATION FACILITY SURVEY

New Braunfels Civic/Convention Center

Jun 29, 2021

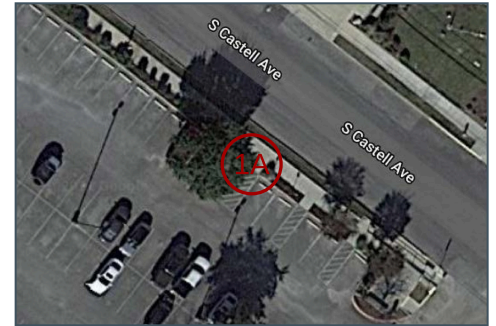
The route from the van accessible parking space to the public sidewalk has an approximate 1" wide gap.

Recommendation: Fill gap with caulking material.

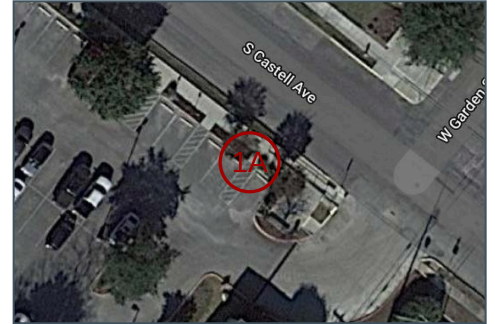
The route from the easternmost accessible parking spaces to the public sidewalk has two approximately 1" wide gaps.

Recommendation: Fill gaps with caulking material.

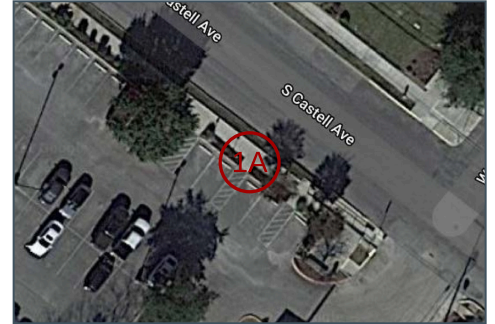
The route from the two center accessible parking spaces to the public sidewalk has two approximately 1" wide gaps.

Recommendation: Fill gaps with caulking material.

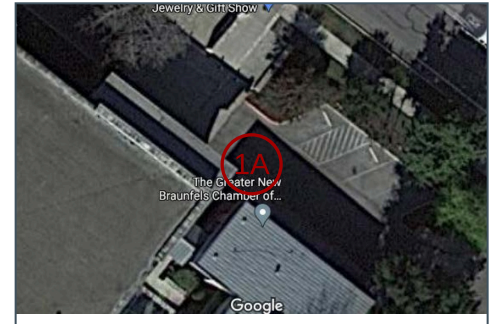
Description
The base of the curb ramp
has a change in level of
approximately 1/2".

Recommendation: Grind the
edge to create a maximum
1:2 bevel.

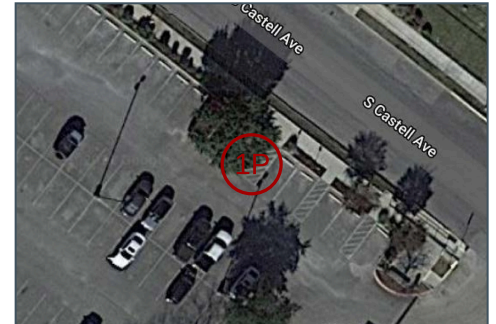
Description
The van accessible parking space and access aisle have a running slope of up to 3.3% and has some cracking and gaps in the asphalt.

Recommendation: Replace asphalt surface at parking space and access aisle.

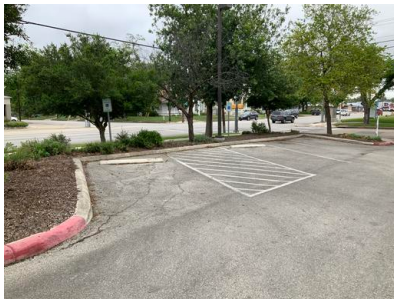
Description
Both accessible parking spaces and the shared access aisle have excessive cross slopes ranging from 3.3% to 3.9%.

Recommendation: Replace asphalt surface at parking spaces.

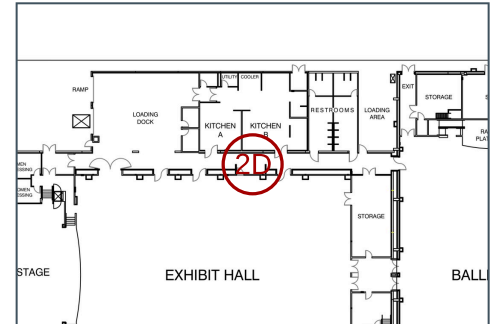
Door vision panels in 12 doors (Exhibit Hall and Kitchen) are positioned with the bottom of the glass 56-1/4" high.

Recommendation: Install doors with vision panels no higher than 43".

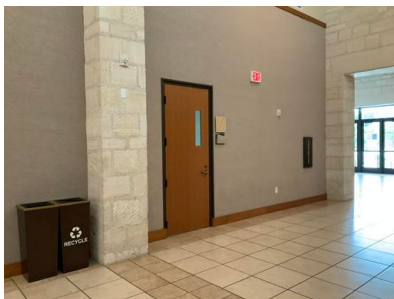
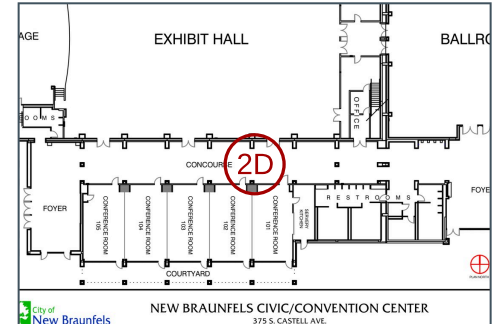
Door vision panels in the 5 conference room doors are positioned with the bottom of the glass more than 43" high.

Recommendation: Install doors with vision panels no higher than 43".

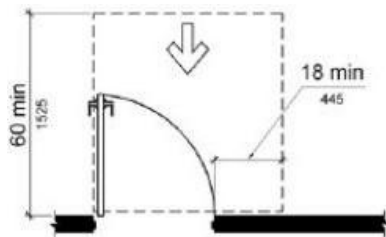
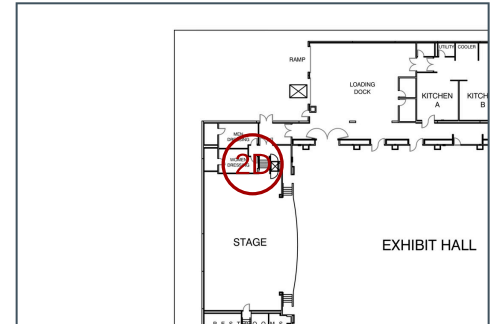
Description
The door has only 17-1/2" of clearance past the strike on the pull side.

Recommendation: Although the clearance is technically less than the allowable, this appears to be within reasonable tolerance. If this door is modified or replaced in the future, correction will be required.

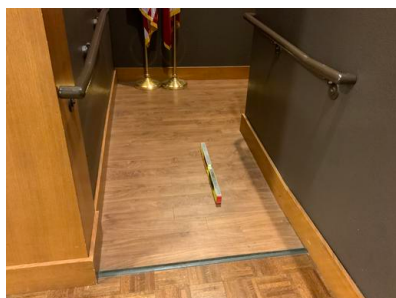
The ramp to the stage has the following noncompliant conditions:

Recommendation: Remove and replace ramp.
