**WESTSIDE COMMUNITY CENTER
2932 S IH Frontage Road
New Braunfels, TX 78130**

ADA SELF-EVALUATION FACILITY SURVEY

New Braunfels Westside Community Center

Jun 29, 2021

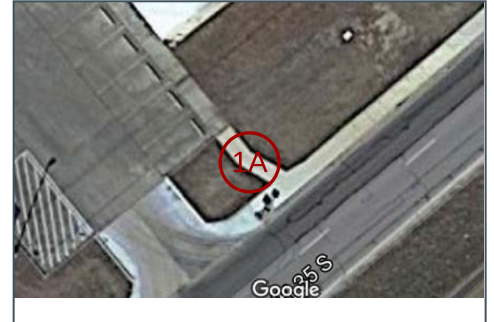
C2

Sidewalk has a cross slope of approximately 2.6%.

Recommendation: Remove and replace sidewalk.

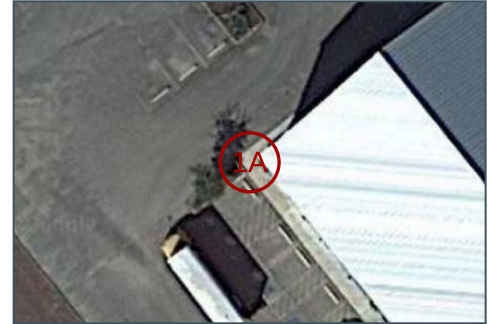
C2

A portion of the sidewalk has
a cross slope of up to 2.7%,
excessive gaps and
excessive change in level.

Recommendation: Remove
and replace sidewalk. (2
panels, 50 SF)

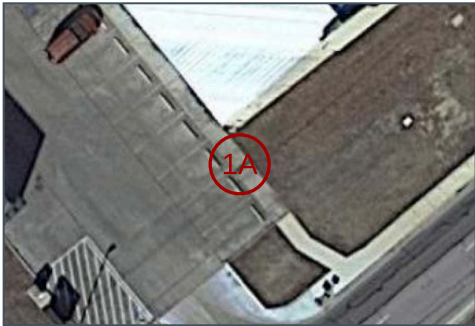
Sheet
C2

Description
The route has an approximate 1" gap on each side of the metal coverplate.

Recommendation: Add caulking material.

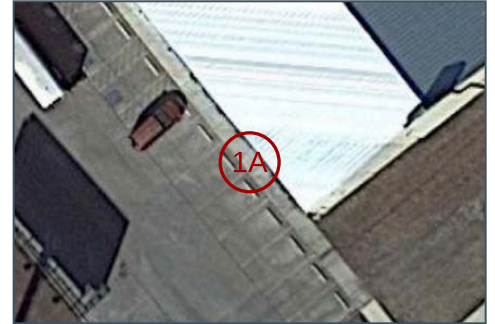
C2

Sidewalk has approximate 1" wide openings between panels in two locations.

Recommendation: Add caulking material.

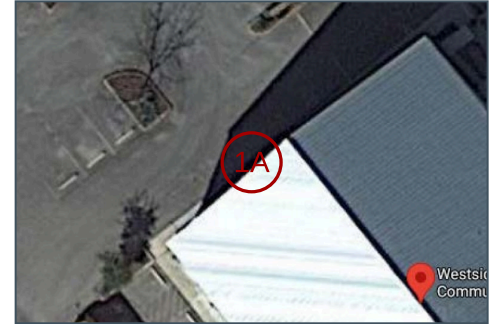
Sheet
C2

Description
Sidewalk has approximate 1"
wide openings between
panels in two locations.

Recommendation: Add
caulking material.

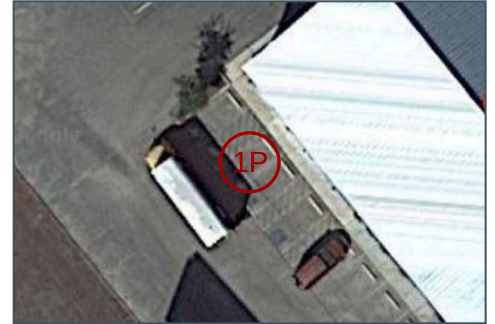
C2

All 4 accessible parking spaces and access aisles have running slopes ranging from 4.3% to 5.9% and a crack in the asphalt.

Recommendation: Remove and replace asphalt in this area.

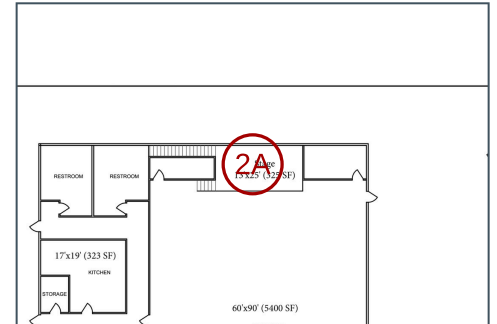
A1

No accessible route is provided to the stage or vending machines.

Recommendation: Install a platform lift for access to the stage.

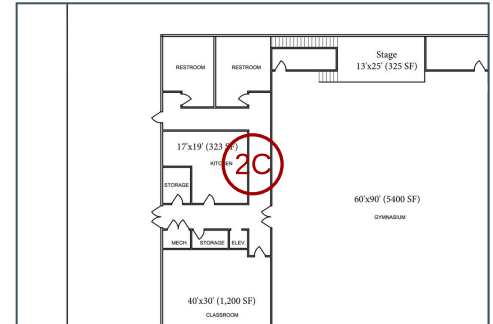
Sheet
A1

Description
The kitchen serving counter is 35" high.

Recommendation: Modify at least a portion of counter to a maximum 34" height.

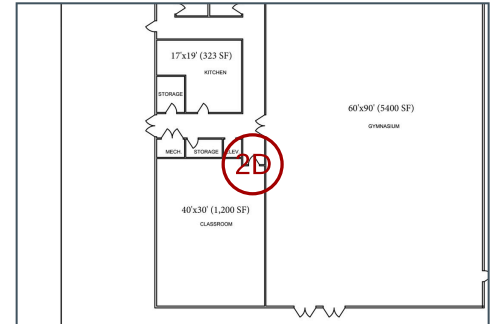
Sheet
A1

Description
Door has only 16" of clearance past the latch on the pull side.

Recommendation: Modify door configuration to provide a minimum 18" clearance past the latch.

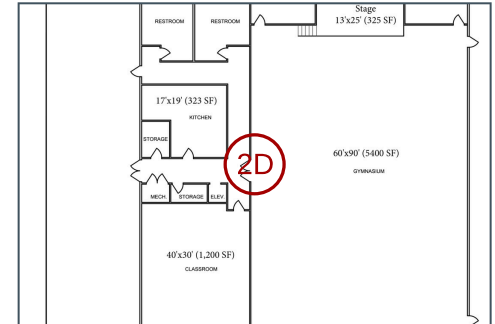
A1

Two sets of double doors have vision panels positioned with the bottom of the glass 44" high.

Recommendation: Replace doors with ones have vision panels positioned with the bottom no more than 43".
(Note: If the doors were installed prior to March 15, 2012, they may enjoy safe harbor until replaced.)

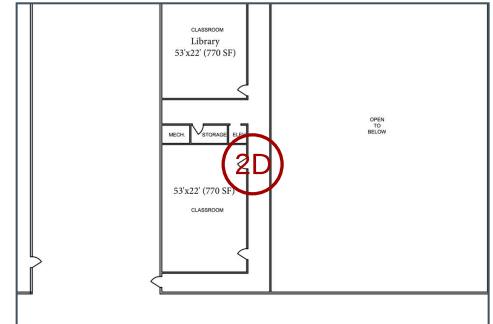
Sheet
A1

Description
Vision panels in 4 doors have the bottom of the glass positioned 45-1/2" high.

Recommendation: Replace doors with ones have vision panels positioned with the bottom no more than 43".
(Note: If the doors were installed prior to March 15, 2012, they may enjoy safe harbor until replaced.)

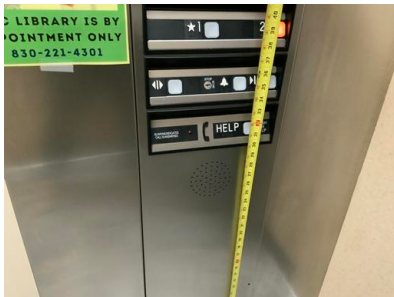
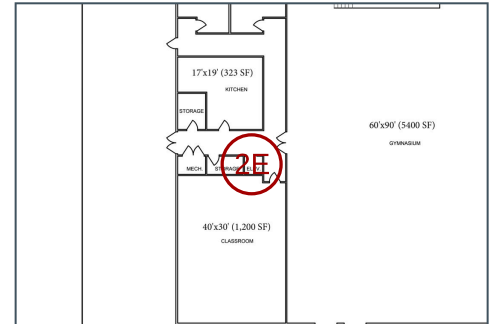
A1

The emergency alarm button is centered 31" high.

Recommendation: Relocate panel with alarm button 35" high minimum.

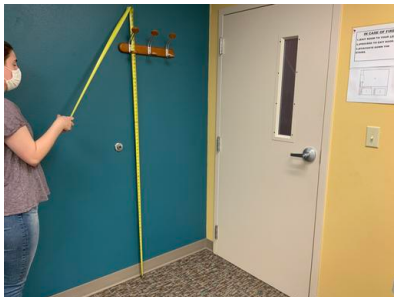
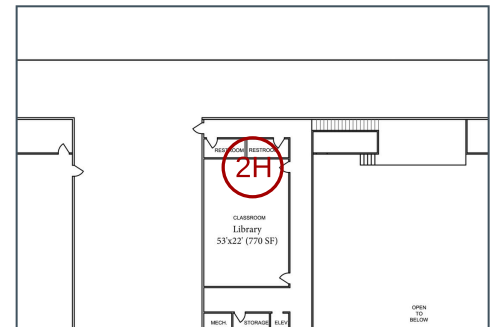
Sheet
A1

Coat hooks are positioned 66" high.

Recommendation: Install at least one hook no higher than 48".

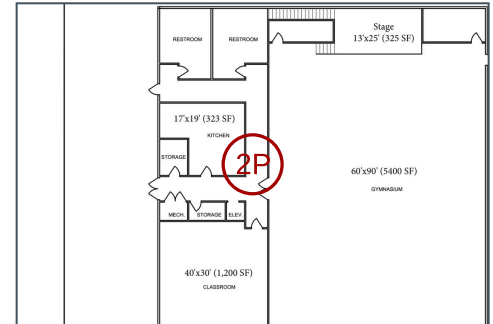
A1

The bleeding control kit projects 10" at 45" high.

Recommendation: Relocate or add cane barrier below.

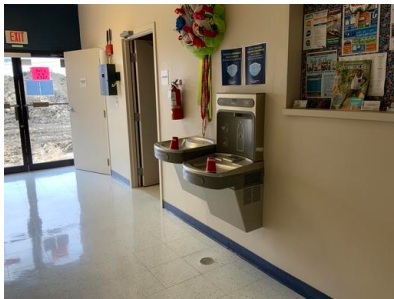
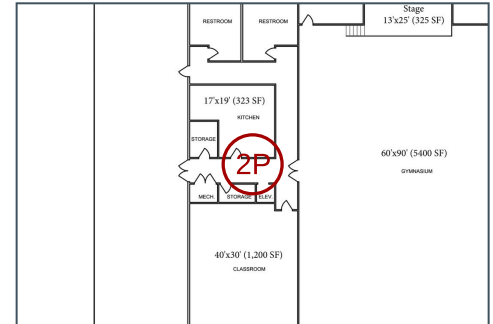
A1

Drinking fountains project approximately 7" from the base at 28-1/2" and 32" high.

Recommendation: Lower accessible fountain so the bottom of the apron is exactly 27", and install an apron to the high fountain.

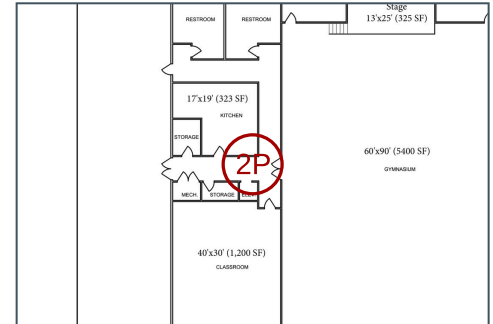
A1

The defibrillator box projects 7-1/2" at 48" high.

Recommendation: Relocate box or install a partially recessed model.

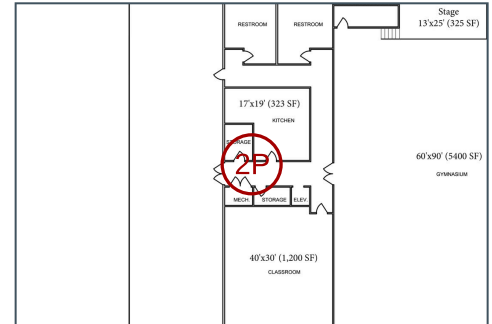
Sheet
A1

Description
Alarm panel box projects 5" from the wall at 52" high.

Recommendation: Provide cane barrier below.

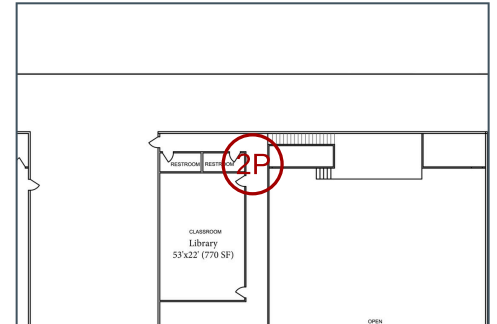
A1

The high drinking fountain projects approximately 7" from the base at 33" high.

Recommendation: Install an apron to the high fountain to bring the bottom to no more than 27" high.

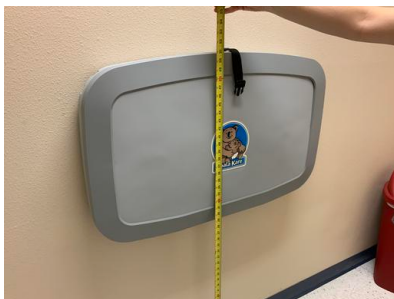
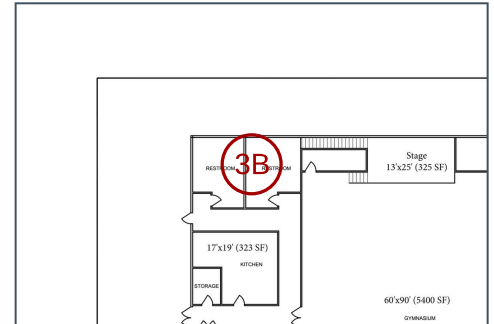
A1

The baby changing station requires a side reach height of 51" to open and has a surface slope of approximately 7.5% within the clear floor space.

Recommendation: Replace baby changing station and locate it where the floor is level and outside of circulation paths. TDLR requires baby changing stations to be considered in their open position when considering protruding objects.

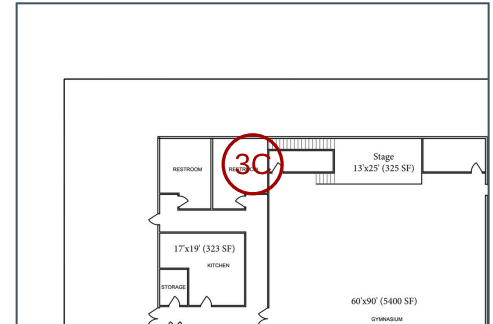
A1

The door to the wheelchair accessible toilet stall is not self-closing and does not have a pull on the inside.

Recommendation: Adjust door hinges. Install door pull.

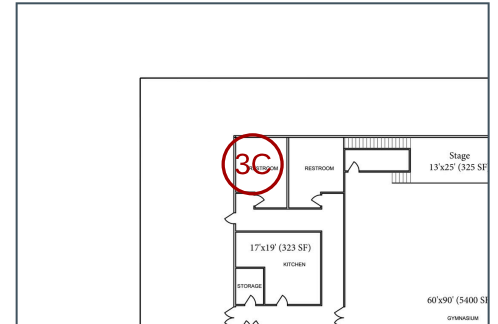
A1

The door to the wheelchair accessible toilet stall is not self-closing and does not have a pull on the inside.

Recommendation: Adjust door hinges. Install door pull.

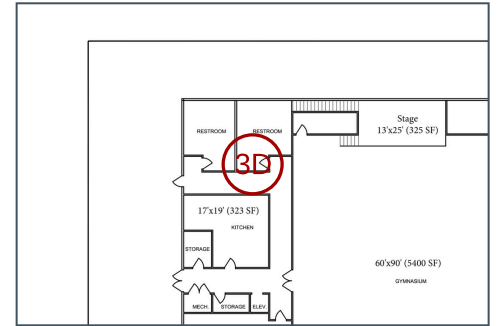
A1

Restroom entry door has only 51" of side approach clearance.

Recommendation: Modify toilet partitions to provide a full 54".

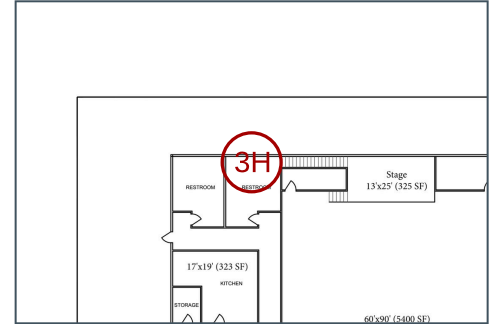
A1

The accessible shower is not equipped with a handheld shower wand (missing), and the knob adjustment requires tight grasping and twisting of the wrist.

Recommendation: Install a compliant handheld shower assembly.

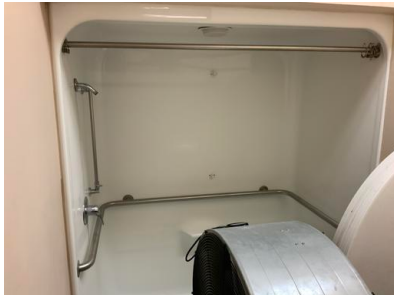
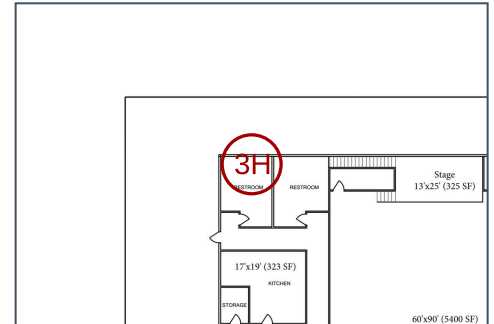
A1

The accessible shower is not equipped with a handheld shower wand (missing), and the knob adjustment requires tight grasping and twisting of the wrist.

Recommendation: Install a compliant handheld shower assembly.
