**CITY OF SAN MARCOS
ADA TRANSITION PLAN
SIGNALIZED INTERSECTION ASSESSMENT
AND COMPLIANCE REPORT**

Location ID: 0000000104
 North-South Cross Street: HUNTER RD
 East-West Cross Street: STAGECOACH TR

Date of Evaluation: 6/25/2014
 Latitude: 29.863822 Longitude: -97.964254
<https://maps.google.com/maps?t=h&q=29.863822+-97.964254>

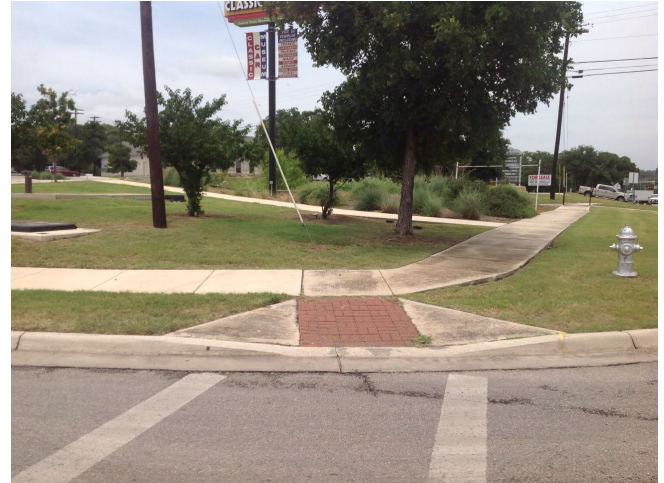
Signalized Intersection: YES
 Accessible Features: YES
 Pedestrian Features Accessible: NO

Ramp Elements	Curb ramp provided where an accessible route crosses a barrier:	YES
	Is the slope of the ramp 1:12 or less:	NO
	Transition from curb ramp slope to roadway free from abrupt changes, no greater than 1:20:	YES
	Ramp is at least 36" wide:	YES
	Ramp surface is stable, firm, and slip resistant:	YES
Flare	Flares (if present) are 1:10 or less measured along the curb line; or If landing at top of ramp is not provided flares are 1:12 or less:	YES
Detectable Warning Surface	Curb ramp is located such that it does not project into roadway or parking aisles:	N/A
	Detectable warning is present:	NO
	DWS maintains correct geometric controls; 0.9" diameter domes, 0.2" in height, spaced at 2.35" and visually contrasts adjacent ramp surface:	NO
Special Ramps	Ramp maintains defined edges parallel to direction of pedestrian travel; maintains 4'x4' turning pad contained in crosswalk; flared sides 24" segment on each side of ramp within crosswalk lines:	YES

Ramp is located so they will not be obstructed by parked vehicles:	N/A
	Ramp wholly contained within the crosswalk lines:	YES
	If island is present; Island maintains a cut through at street level or ramps on either side with landing between them:	YES
