**CITY OF SAN MARCOS
ADA TRANSITION PLAN
SIGNALIZED INTERSECTION ASSESSMENT
AND COMPLIANCE REPORT**

Location ID: 0000000139
 North-South Cross Street: SAN ANTONIO ST
 East-West Cross Street: GUADALUPE ST

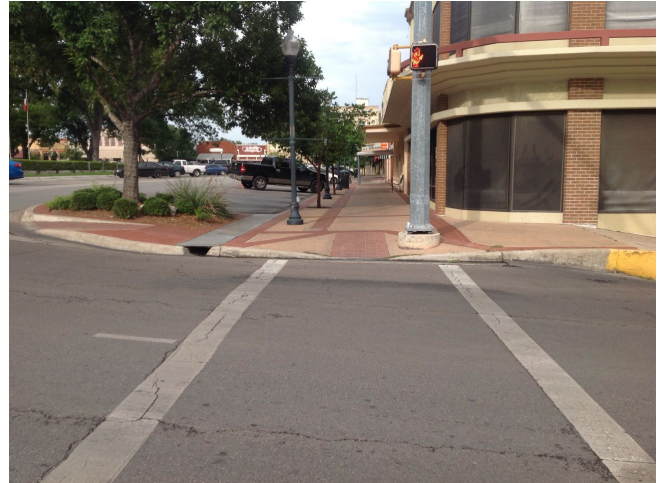
Ramp Elements	Curb ramp provided where an accessible route crosses a barrier:	YES
	Is the slope of the ramp 1:12 or less:	YES
	Transition from curb ramp slope to roadway free from abrupt changes, no greater than 1:20:	NO
	Ramp is at least 36" wide:	YES
	Ramp surface is stable, firm, and slip resistant:	YES
Flare	Flares (if present) are 1:10 or less measured along the curb line; or If landing at top of ramp is not provided flares are 1:12 or less:	YES
Detectable Warning Surface	Curb ramp is located such that it does not project into roadway or parking aisles:	N/A
	Detectable warning is present:	YES
	DWS maintains correct geometric controls; 0.9" diameter domes, 0.2" in height, spaced at 2.35" and visually contrasts adjacent ramp surface:	NO
Special Ramps	Ramp maintains defined edges parallel to direction of pedestrian travel; maintains 4'x4' turning pad contained in crosswalk; flared sides 24" segment on each side of ramp within crosswalk lines:	NO

Ramp is located so they will not be obstructed by parked vehicles:	N/A
	Ramp wholly contained within the crosswalk lines:	YES
	If island is present; Island maintains a cut through at street level or ramps on either side with landing between them:	N/A
