**CITY OF SAN MARCOS
ADA TRANSITION PLAN
SIGNALIZED INTERSECTION ASSESSMENT
AND COMPLIANCE REPORT**

Location ID: 0000000152
 North-South Cross Street: SESSOM DR
 East-West Cross Street: LBJ DR

Date of Evaluation: 6/27/2014
 Latitude: 29.891390 Longitude: -97.941508
<https://maps.google.com/maps?t=h&q=29.891390+-97.941508>

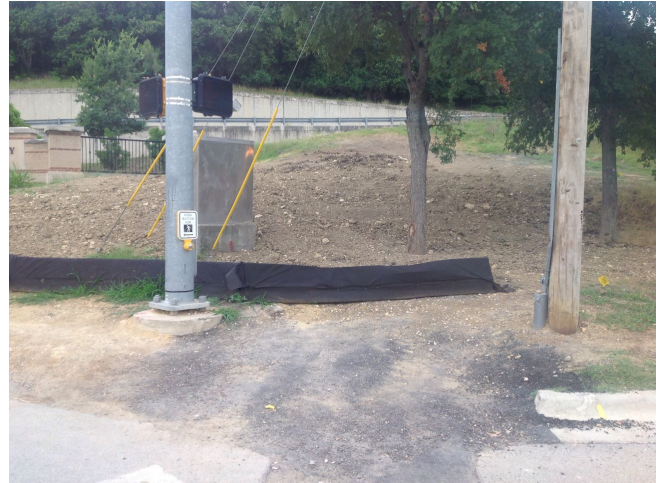
Signalized Intersection: YES
 Accessible Features: YES
 Pedestrian Features Accessible: NO

Ramp Elements	Curb ramp provided where an accessible route crosses a barrier:	NO
	Is the slope of the ramp 1:12 or less:	NO
	Transition from curb ramp slope to roadway free from abrupt changes, no greater than 1:20:	NO
	Ramp is at least 36" wide:	NO
	Ramp surface is stable, firm, and slip resistant:	NO
Flare	Flares (if present) are 1:10 or less measured along the curb line; or If landing at top of ramp is not provided flares are 1:12 or less:	NO
Detectable Warning Surface	Curb ramp is located such that it does not project into roadway or parking aisles:	N/A
	Detectable warning is present:	NO
	DWS maintains correct geometric controls; 0.9" diameter domes, 0.2" in height, spaced at 2.35" and visually contracts adjacent ramp surface:	NO
Special Ramps	Ramp maintains defined edges parallel to direction of pedestrian travel; maintains 4'x4' turning pad contained in crosswalk; flared sides 24" segment on each side of ramp within crosswalk lines:	N/A

Ramp is located so they will not be obstructed by parked vehicles:	N/A
	Ramp wholly contained within the crosswalk lines:	N/A
	If island is present; Island maintains a cut through at street level or ramps on either side with landing between them:	N/A
