CITY OF SAN MARCOS ADA TRANSITION PLAN SIGNALIZED INTERSECTION ASSESSMENT AND COMPLIANCE REPORT

Location ID: 000000164
 North-South Cross Street: THORPE LN
 East-West Cross Street: EASTWOOD ST

Date of Evaluation: 6/27/2014

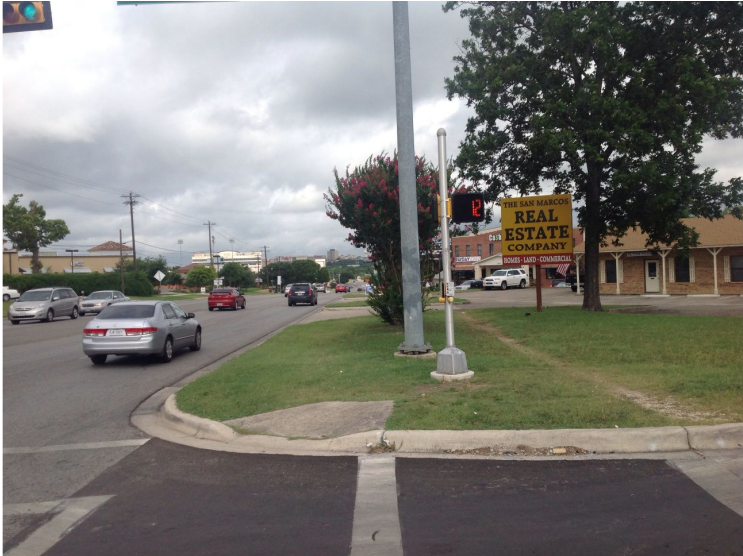
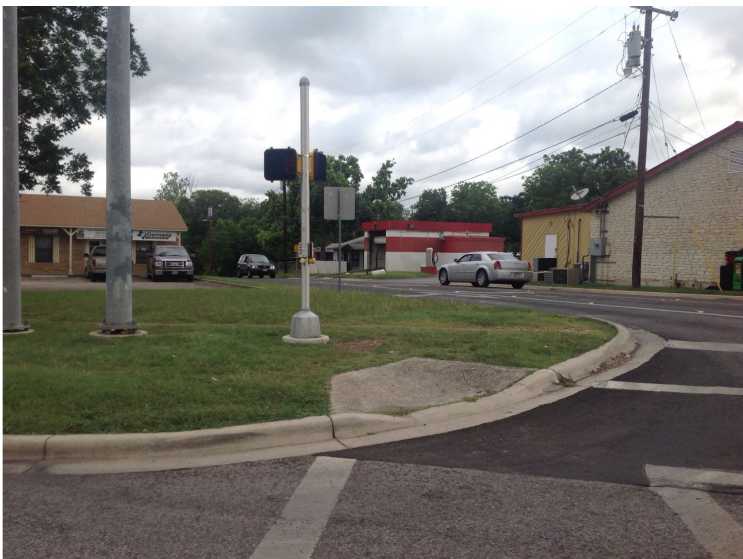
Location Photos

Ramp Elements	Curb ramp provided where an accessible route crosses a barrier:	YES
	Is the slope of the ramp 1:12 or less:	NO
	Transition from curb ramp slope to roadway free from abrupt changes, no greater than 1:20:	NO
	Ramp is at least 36" wide:	YES
	Ramp surface is stable, firm, and slip resistant:	YES
Flare	Flares (if present) are 1:10 or less measured along the curb line; or If landing at top of ramp is not provided flares are 1:12 or less:	NO
Detectable Warning Surface	Curb ramp is located such that it does not project into roadway or parking aisles:	N/A
	Detectable warning is present:	NO
	DWS maintains correct geometric controls; 0.9" diameter domes, 0.2" in height, spaced at 2.35" and visually contracts adjacent ramp surface:	NO
Special Ramps	Ramp maintains defined edges parallel to direction of pedestrian travel; maintains 4'x4' turning pad contained in crosswalk; flared sides 24" segment on each side of ramp within crosswalk lines:	YES
