**CITY OF SAN MARCOS
ADA TRANSITION PLAN
SIGNALIZED INTERSECTION ASSESSMENT
AND COMPLIANCE REPORT**

Location ID: 0000000232
 North-South Cross Street: HUNTER RD
 East-West Cross Street: STAGECOACH TR

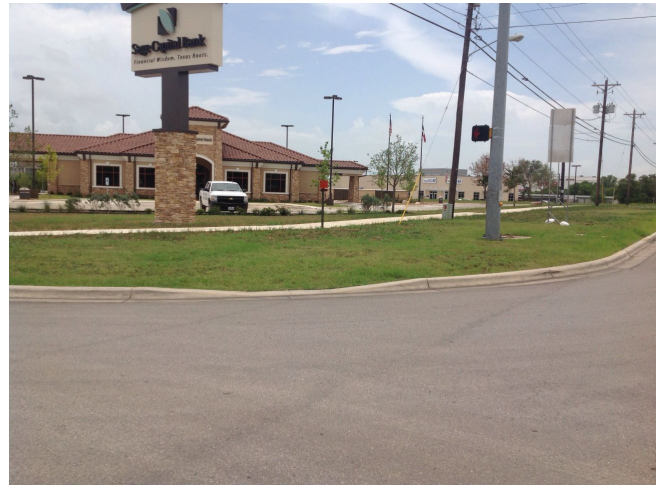
Signalized Intersection: YES
 Accessible Features: YES
 Pedestrian Features Accessible: NO

Ramp Elements	Curb ramp provided where an accessible route crosses a barrier:	NO
	Is the slope of the ramp 1:12 or less:	NO
	Transition from curb ramp slope to roadway free from abrupt changes, no greater than 1:20:	NO
	Ramp is at least 36" wide:	NO
	Ramp surface is stable, firm, and slip resistant:	NO
Flare	Flares (if present) are 1:10 or less measured along the curb line; or If landing at top of ramp is not provided flares are 1:12 or less:	NO
Detectable Warning Surface	Curb ramp is located such that it does not project into roadway or parking aisles:	N/A
	Detectable warning is present:	NO
	DWS maintains correct geometric controls; 0.9" diameter domes, 0.2" in height, spaced at 2.35" and visually contracts adjacent ramp surface:	NO
Special Ramps	Ramp maintains defined edges parallel to direction of pedestrian travel; maintains 4'x4' turning pad contained in crosswalk; flared sides 24" segment on each side of ramp within crosswalk lines:	N/A
