Utility Conflict Report

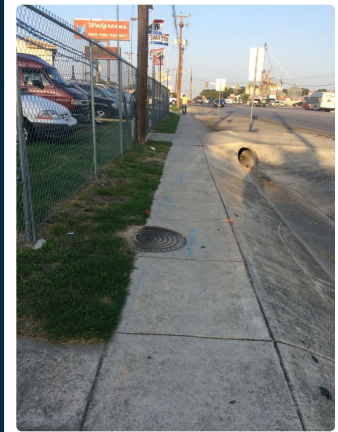
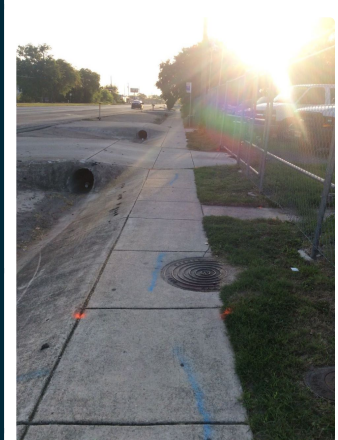
OWNER	Utility	SAWS	Corridor	RIGSBY	SITE PHOTOS
	Contact	NINA BITTLE	ID	2097	
GENERAL INFO	Utility	SANITARY SEWER			
	Size and Material	STANDARD MANHOLE, CAST IRON			
	Utility Conflict Description	MANHOLE WITHIN PROPOSED SIDEWALK			
	Longitudinal or Crossing	CROSSING			
	Placement Relative to ROW	INSIDE			
LOCATION	Sheet No.	277			
	Station Origin				
	Start Station	564+51.60	End Station		
	Start Offset	25.42	End Offset		
	Latitude	29.398394056	Longitude	-98.405890185999993	
SUE	Level of Investigation Req'd	NONE			
	Test Hole No	N/A			
	Test Hole Depth	N/A			
RESOLUTION	Recommended Action	MINIMIZE - PROTECT IN PLACE			
	Estimated Resolution Date				
	Resolution Status	UTILITY CONFLICT RESOLVED			
	Comment	ADJUST MANHOLE LID TO PROPOSED GRADE DURING CONSTRUCTION (1" VERTICAL CHANGE ANTICIPATED)			
Date Collected		8/14/2017 7:23:12 PM	Date Modified		8/17/2018 2:20:15 PM
