Utility Conflict Report

OWNER	Utility	SAWS	Corridor	SW MILITARY	SITE PHOTOS	
	Contact	ANN PECHE	ID	7125		
GENERAL INFO	Utility	WATER

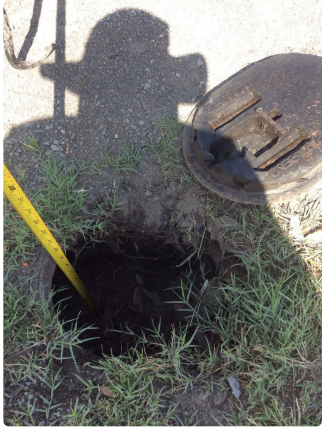
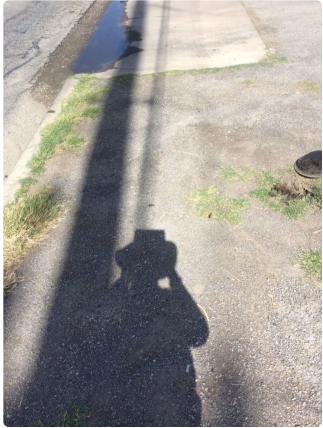
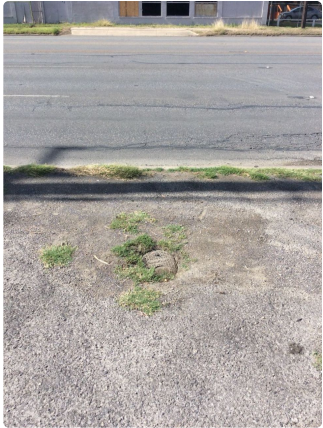
Size and Material	STANDARD WATER METER, STEEL				
	Accessible Route	ASSET IS OUTSIDE ACCESSIBLE ROUTE				
	Longitudinal or Crossing	CROSSING				
	Placement Relative to ROW	INSIDE ROW				
LOCATION	Sheet No.	186

Test Hole No	N/A				
	Test Hole Depth	N/A				
RESOLUTION	Recommended Action	MINIMIZE - PROTECT IN PLACE				
	Estimated Resolution Date					
	Resolution Status	UTILITY OWNER INFORMED OF UTILITY				
	Comment	Top of meter to surface = 8" Rubber lid Back of curb to meter = 5'-6"				
Date Collected		8/6/2018 10:14:23 AM		Date Modified 11/28/2018 6:59:12 AM
