Utility Conflict Report

OWNER	Utility	SAWS	Corridor	NOGALITOS	SITE PHOTOS	
	Contact	NINA BITTLE	ID	3068		
GENERAL INFO	Utility	WATER

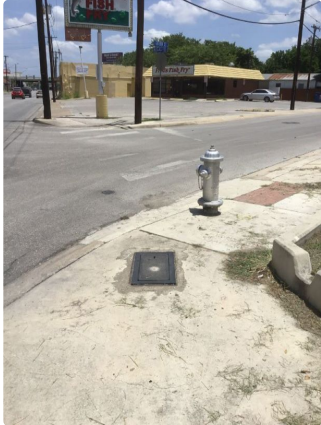
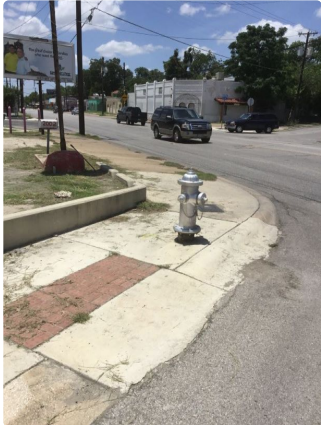
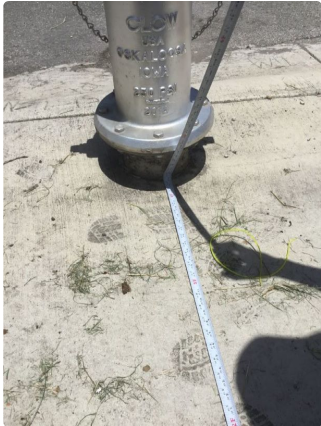
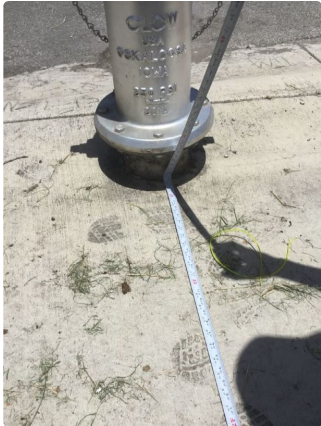
Size and Material	STANDARD FIRE HYDRANT				
	Accessible Route	ASSET IS INSIDE ACCESSIBLE ROUTE				
	Longitudinal or Crossing	CROSSING				
	Placement Relative to ROW	INSIDE ROW				
LOCATION	Sheet No.

Estimated Resolution Date	8/13/2018				
	Resolution Status	NO RESOLUTION WAS REQUIRED				
	Comment	Hydrant to face of wall = 4'-3" Sidewalk width = 5'-7"				
Date Collected		7/11/2018 1:23:31 PM		Date Modified	8/14/2018 4:38:26 PM

Test Hole No	N/A				
	Test Hole Depth	N/A				
RESOLUTION	Recommended Action	NO CONFLICT
