Utility Conflict Report

| OWNER | Utility | CPS | Corridor | NOGALITOS | SITE PHOTOS | | |
| GENERAL INFO | Utility | ELECTRIC | | | | | |
| | Size and Material | STANDARD POWER POLE, TIMBER | | | | | |

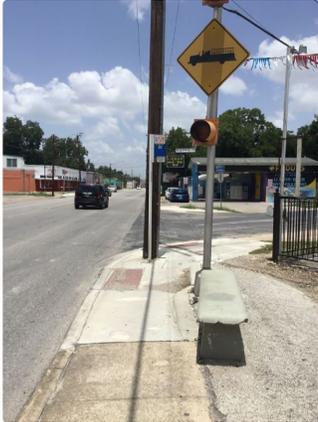
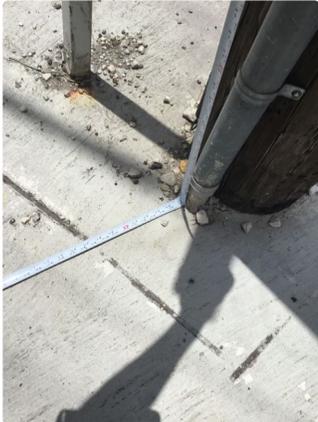
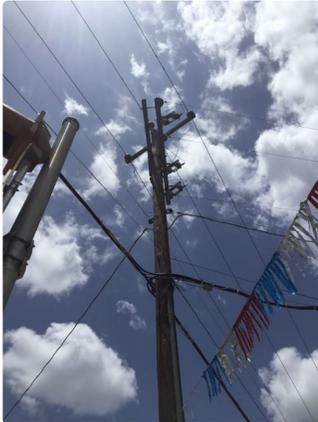
| | Accessible Route | ASSET IS INSIDE ACCESSIBLE ROUTE | | | | | |
| | Longitudinal or Crossing | CROSSING | | | | | |
| | Placement Relative to ROW | INSIDE ROW | | | | | |
| | Station | 127+19.47 | | | | | |
| | Comment | Pole marking: P1557 Conduit to face of wall = 3'-6" Adjacent to VIA bus stop no. 62626 | | | | | |

| RESOLUTION | Recommended Action | NO CONFLICT | | | | | |
| | Resolution Status | NO RESOLUTION WAS REQUIRED | | | | | |
