HINMAN ISLAND PARK
Hinman Island Drive
New Braunfels, TX 78130

Hinman Island Park

Prepared by Kim Goss

City of New Braunfels ADA Transition Plan

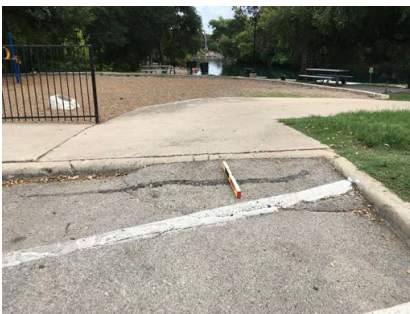
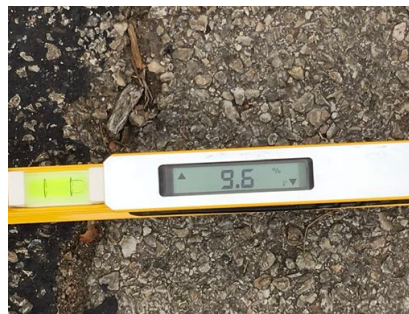
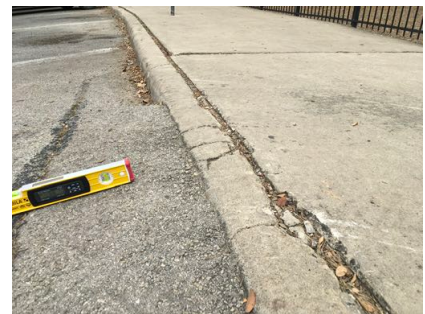
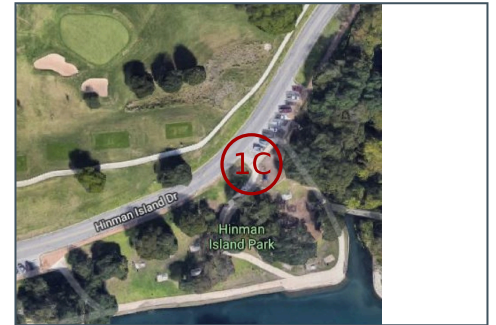
#62 Priority 1: Curb Ramps

The existing built up curb ramp has a running slope of 9.6%, no edge protection and a rounded change in level at the top landing.

Recommendation: Remove and reinstall curb ramp.
Note: Ramp may not project into the access aisle of the van accessible parking space. See Item #61.

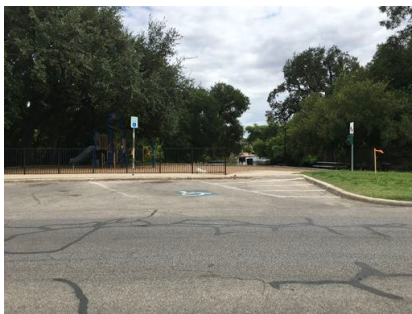
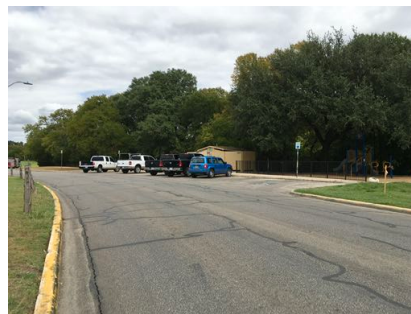
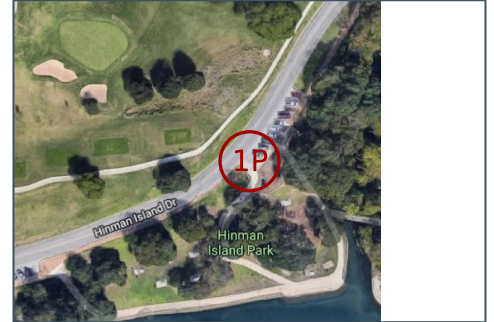
#61 Priority 1: Parking

A total of 20 parking spaces are provided at the park. One standard accessible parking space is provided near the restroom building. No van space is provided.

Recommendation: Restripe parking to provide an 11-foot wide parking space with a 5-foot wide aisle, or an 8-foot parking space with an 8-foot wide aisle. Relocate sign as necessary and add a van designation.

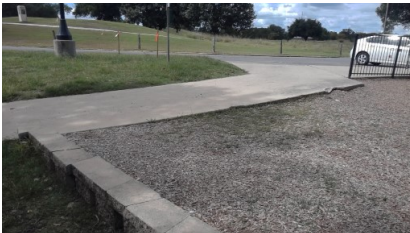
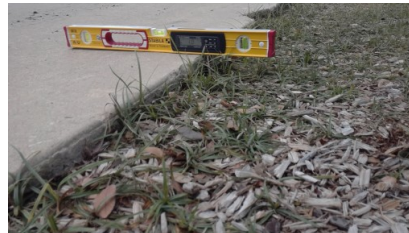
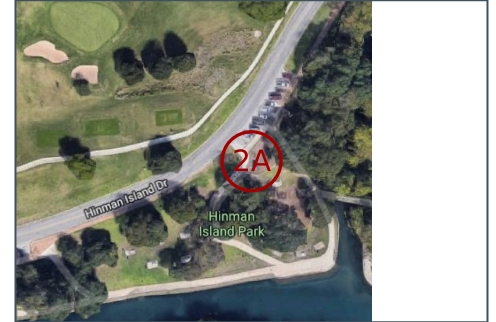
#26 Priority 2: Accessible Route

The transition from the sidewalk to the playground surface has a 1- to 4-inch change in level.

Recommendation: Install a ramp with a slope of no more than 1:12 that dives beneath the loose fill surface to accommodate erosion and displacement.

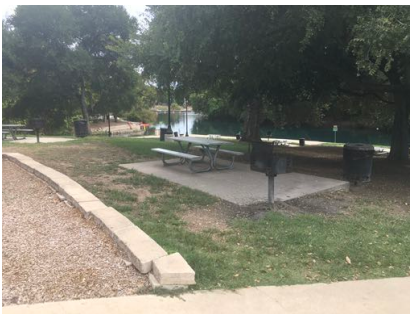
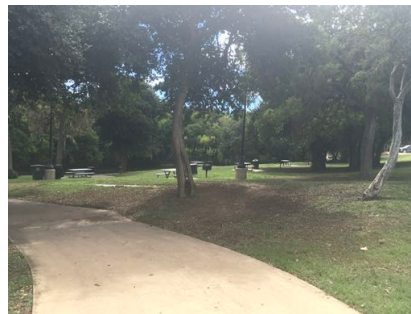
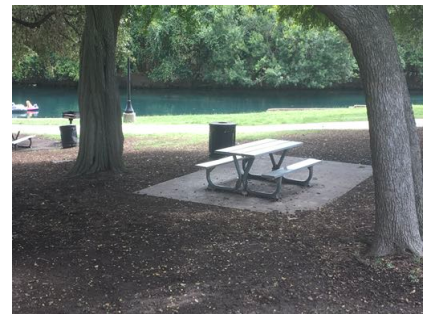
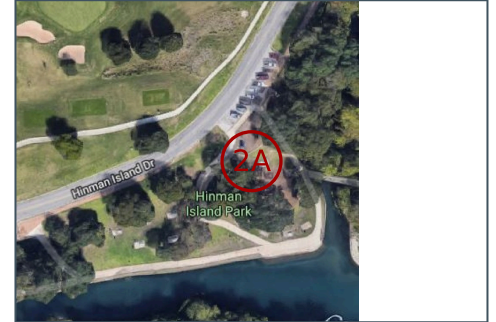
#65 Priority 2: Accessible Routes

None of the picnic tables or grills are on an accessible route. Picnic tables do not have a clear floor space for access.

Recommendation: Install a sidewalk for access to the picnic table and grill closest to the playground (approximately 32 s.f.).
Replace the picnic table with one having a minimum 30-inch wide, 27-inch high and 17-inch deep knee space for a wheelchair.

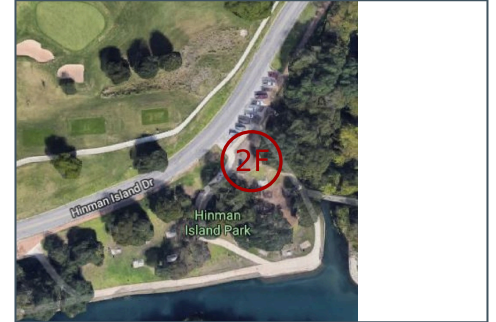
#27 Priority 2: Recreation Areas

On the day of inspection, the shredded bark playground surface was irregular and not compacted.

Recommendation: Regular maintenance is required for loose fill material to ensure that the surface is accessible at all times.

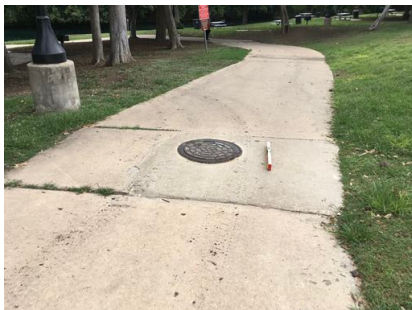
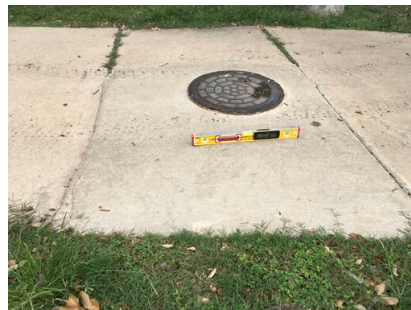
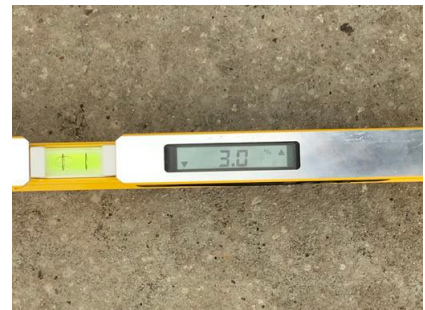
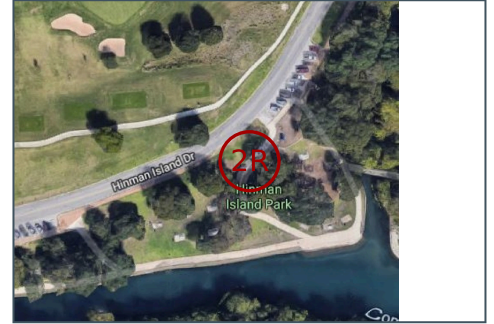
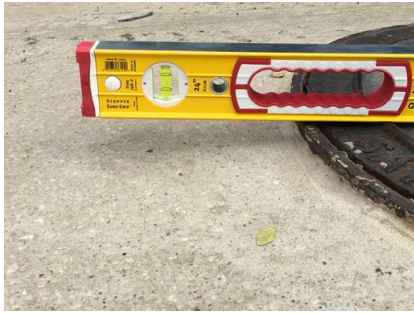
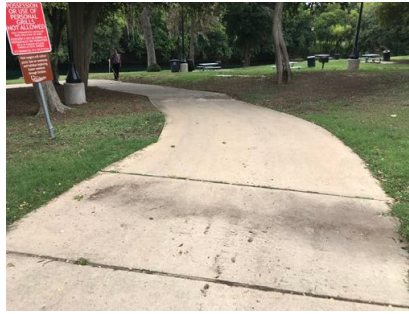
#64 Priority 2: Ramps

The sidewalk leading from the playground and parking to the river access point has a slope in excess of 5%, but does not have handrails. The uppermost landing has a slope in excess of 2% where the concrete is humped at the manhole cover.

Recommendation: Install handrails on both sides (approximately 500 l.f.). Remove and reinstall landing to have a slope of no more than 2% in any direction.

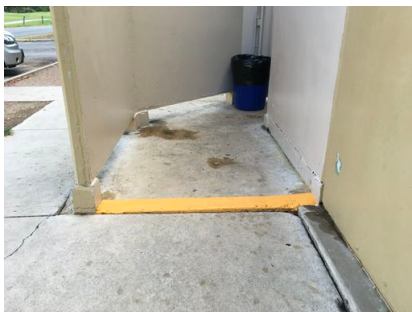
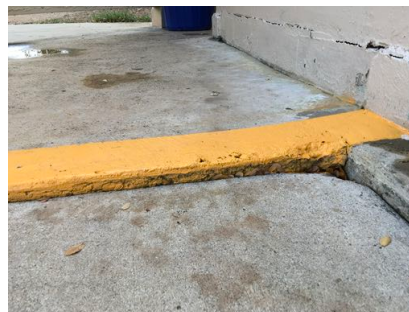
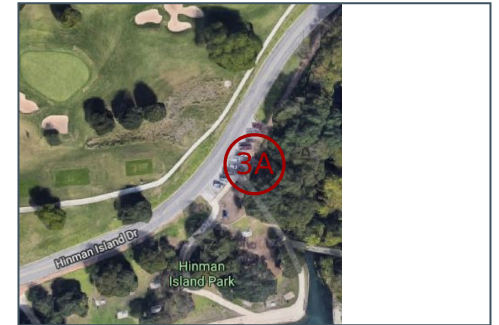
#39 Priority 3: Accessible Routes

The entry to the restroom has a 1- to 1 1/2-inch change in level.

Recommendation: Remove and replace sidewalk to create a smooth transition (40 s.f.). (Note: It is our understanding that these restrooms are slated to be replaced in the coming months.)

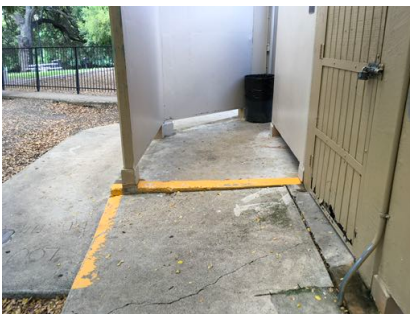
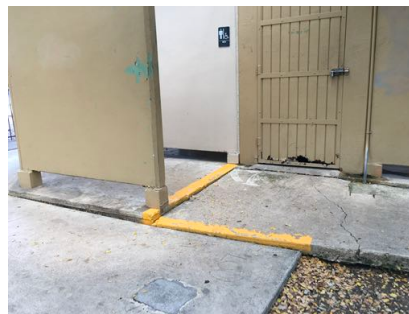
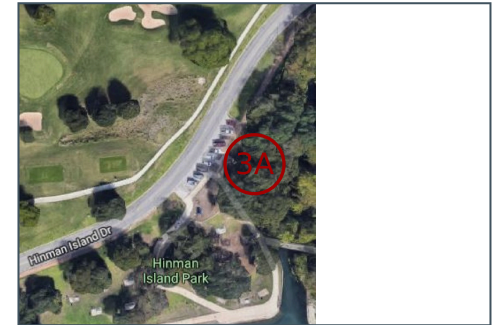
#40 Priority 3: Accessible Routes

The entry to the restroom has a 1- to 2 1/2-inch change in level at the entry and also from the lower sidewalk.

Recommendation: Remove and replace sidewalk to create a ramp and level landing (65 s.f.). (Note: It is our understanding that these restrooms are slated to be replaced in the coming months.)

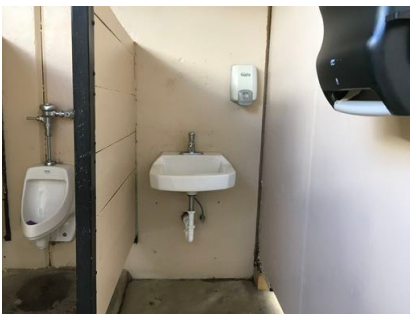
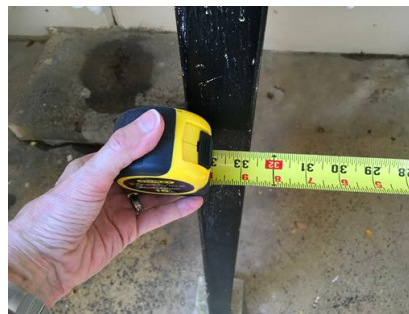
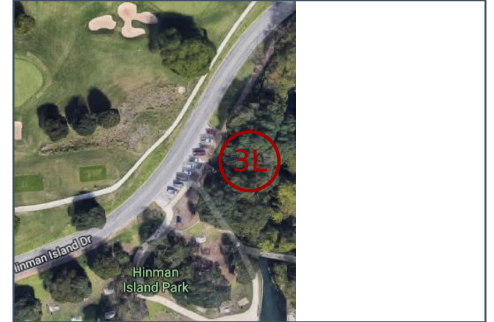
#41 Priority 3: Lavatories

The lavatory is located in an alcove that is greater than 24 inches deep and only 33 inches wide.

Recommendation: Increase the width to 36 inches minimum. See related comments in Item #17.
(Note: It is our understanding that these restrooms are slated to be replaced in the coming months.)

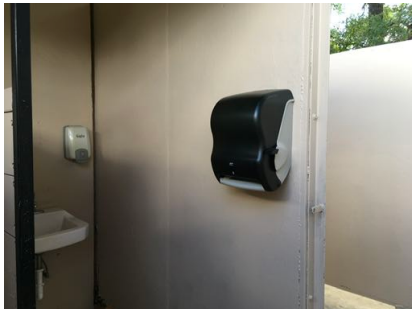
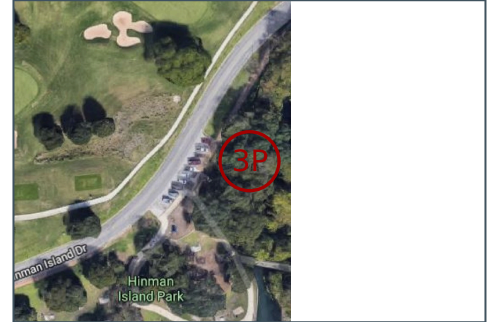
#43 Priority 3: Protruding Object

The paper towel dispenser projects 9 inches at a height of 48 inches.

Recommendation: Replace dispenser with one that projects no more than 4 inches from the wall. (Note: It is our understanding that these restrooms are slated to be replaced in the coming months.)

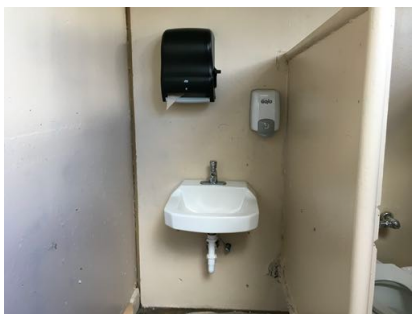
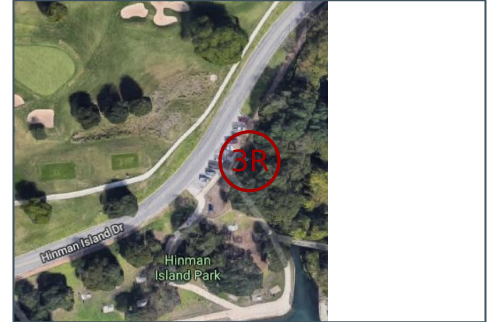
#38 Priority 3: Reach Range

The soap dispenser is mounted with the lever 48 inches high, and the paper towel dispenser is mounted with the lever 60 inches high. A maximum 44-inch height is allowed for forward reach over an obstruction.

Recommendation: Remove and relocate dispensers so that the highest operable part is no more than 44 inches high. (Note: It is our understanding that these restrooms are slated to be replaced in the coming months.)

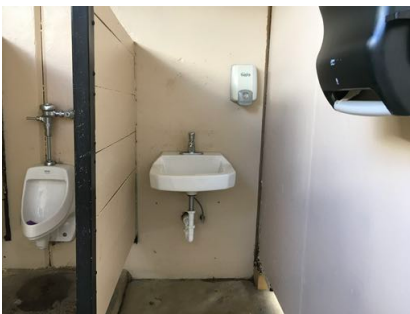
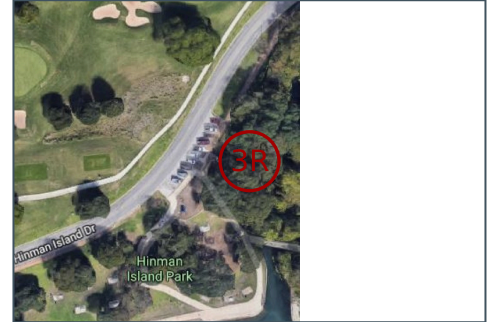
#42 Priority 3: Reach Range

The soap dispenser is mounted with the dispensing lever 49 inches high.

Reposition the dispenser with the dispensing lever no higher than 44 inches.
