**CITY OF SAN MARCOS  
ADA TRANSITION PLAN  
SIGNALIZED INTERSECTION ASSESSMENT  
AND COMPLIANCE REPORT**

Location ID: 0000000069  
 North-South Cross Street: BARNES DR  
 East-West Cross Street: MCCARTY LN

Signalized Intersection: YES  
 Accessible Features: NO  
 Pedestrian Features Accessible: NO

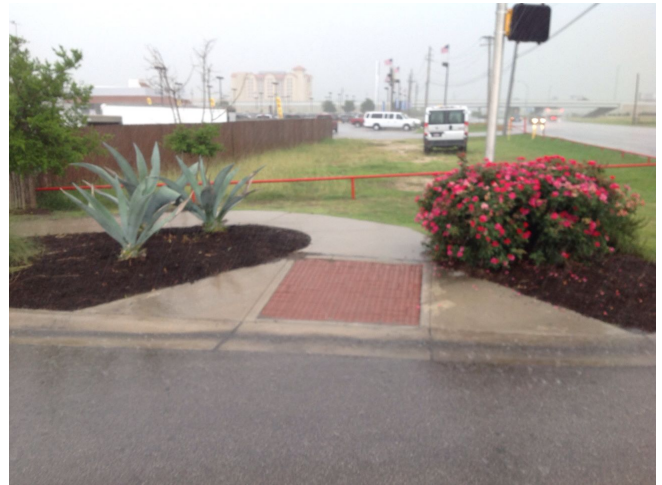
<b>Ramp Elements</b>	Curb ramp provided where an accessible route crosses a barrier:	YES
	Is the slope of the ramp 1:12 or less:	YES
	Transition from curb ramp slope to roadway free from abrupt changes, no greater than 1:20:	YES
	Ramp is at least 36" wide:	YES
	Ramp surface is stable, firm, and slip resistant:	YES
<b>Flare</b>	Flares (if present) are 1:10 or less measured along the curb line; or If landing at top of ramp is not provided flares are 1:12 or less:	YES
<b>Detectable Warning Surface</b>	Curb ramp is located such that it does not project into roadway or parking aisles:	N/A
	Detectable warning is present:	YES
	DWS maintains correct geometric controls; 0.9" diameter domes, 0.2" in height, spaced at 2.35" and visually contracts adjacent ramp surface:	YES
<b>Special Ramps</b>	Ramp maintains defined edges parallel to direction of pedestrian travel; maintains 4'x4' turning pad contained in crosswalk; flared sides 24" segment on each side of ramp within crosswalk lines:	N/A

Ramp is located so they will not be obstructed by parked vehicles:	N/A
	Ramp wholly contained within the crosswalk lines:	N/A
	If island is present; Island maintains a cut through at street level or ramps on either side with landing between them:	N/A
