**CITY OF SAN MARCOS  
ADA TRANSITION PLAN  
SIGNALIZED INTERSECTION ASSESSMENT  
AND COMPLIANCE REPORT**

Location ID: 000000076  
 North-South Cross Street: SH 123  
 East-West Cross Street: DE ZAVALA DR

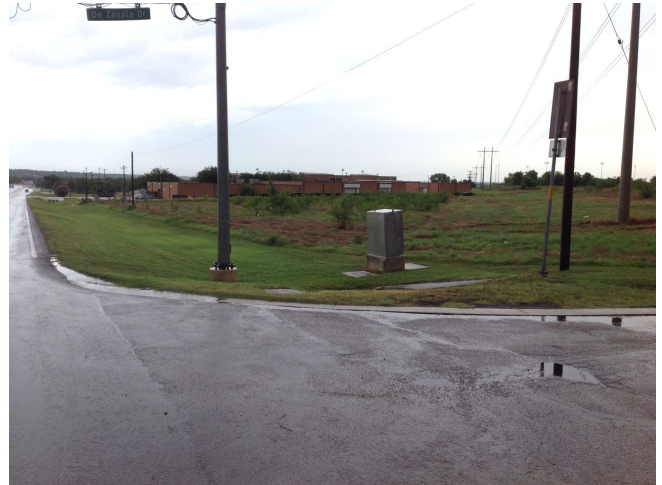
Signalized Intersection: YES  
 Accessible Features: NO  
 Pedestrian Features Accessible: NO

<b>Ramp Elements</b>	Curb ramp provided where an accessible route crosses a barrier:	NO
	Is the slope of the ramp 1:12 or less:	NO
	Transition from curb ramp slope to roadway free from abrupt changes, no greater than 1:20:	NO
	Ramp is at least 36" wide:	NO
	Ramp surface is stable, firm, and slip resistant:	NO
<b>Flare</b>	Flares (if present) are 1:10 or less measured along the curb line; or If landing at top of ramp is not provided flares are 1:12 or less:	N/A
<b>Detectable Warning Surface</b>	Curb ramp is located such that it does not project into roadway or parking aisles:	N/A
	Detectable warning is present:	NO
	DWS maintains correct geometric controls; 0.9" diameter domes, 0.2" in height, spaced at 2.35" and visually contracts adjacent ramp surface:	NO
<b>Special Ramps</b>	Ramp maintains defined edges parallel to direction of pedestrian travel; maintains 4'x4' turning pad contained in crosswalk; flared sides 24" segment on each side of ramp within crosswalk lines:	N/A

Ramp is located so they will not be obstructed by parked vehicles:	N/A
	Ramp wholly contained within the crosswalk lines:	N/A
	If island is present; Island maintains a cut through at street level or ramps on either side with landing between them:	N/A
