CITY OF SAN MARCOS ADA TRANSITION PLAN SIGNALIZED INTERSECTION ASSESSMENT AND COMPLIANCE REPORT

Location ID: 000000080
 North-South Cross Street: SH 123
 East-West Cross Street: HAYS ST

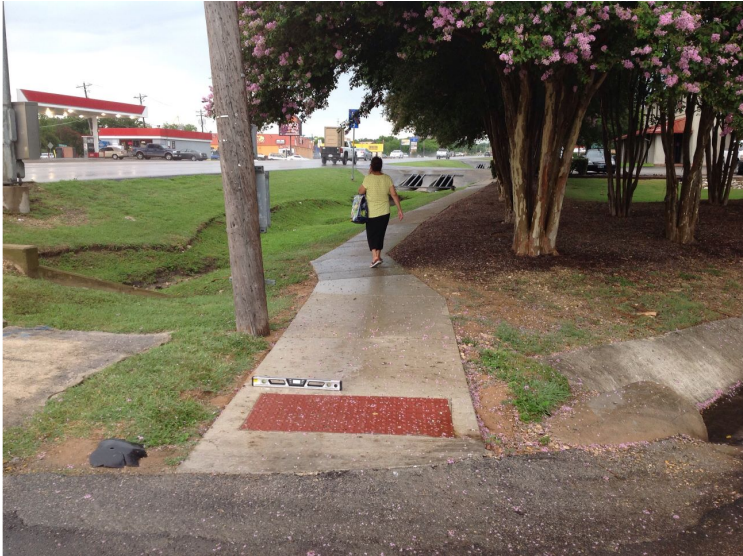
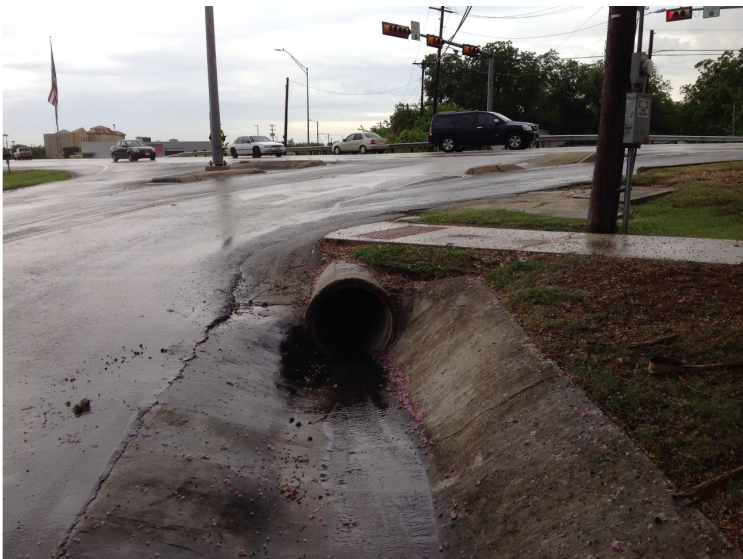
Location Photos

Ramp Elements	Curb ramp provided where an accessible route crosses a barrier:	NO
	Is the slope of the ramp 1:12 or less:	NO
	Transition from curb ramp slope to roadway free from abrupt changes, no greater than 1:20:	NO
	Ramp is at least 36" wide:	NO
	Ramp surface is stable, firm, and slip resistant:	NO
Flare	Flares (if present) are 1:10 or less measured along the curb line; or If landing at top of ramp is not provided flares are 1:12 or less:	NO
Detectable Warning Surface	Curb ramp is located such that it does not project into roadway or parking aisles:	N/A
	Detectable warning is present:	YES
	DWS maintains correct geometric controls; 0.9" diameter domes, 0.2" in height, spaced at 2.35" and visually contracts adjacent ramp surface:	YES
Special Ramps	Ramp maintains defined edges parallel to direction of pedestrian travel; maintains 4'x4' turning pad contained in crosswalk; flared sides 24" segment on each side of ramp within crosswalk lines:	NO

Ramp is located so they will not be obstructed by parked vehicles:	N/A
	Ramp wholly contained within the crosswalk lines:	N/A
	If island is present; Island maintains a cut through at street level or ramps on either side with landing between them:	N/A
