**CITY OF SAN MARCOS
ADA TRANSITION PLAN
SIGNALIZED INTERSECTION ASSESSMENT
AND COMPLIANCE REPORT**

Location ID: 0000000085
 North-South Cross Street: IH 35 SBFR
 East-West Cross Street: SH 123

Date of Evaluation: 6/25/2014

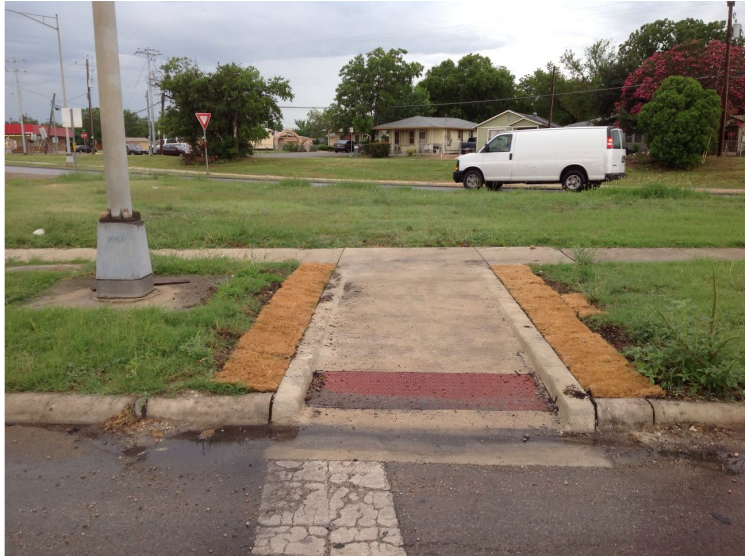
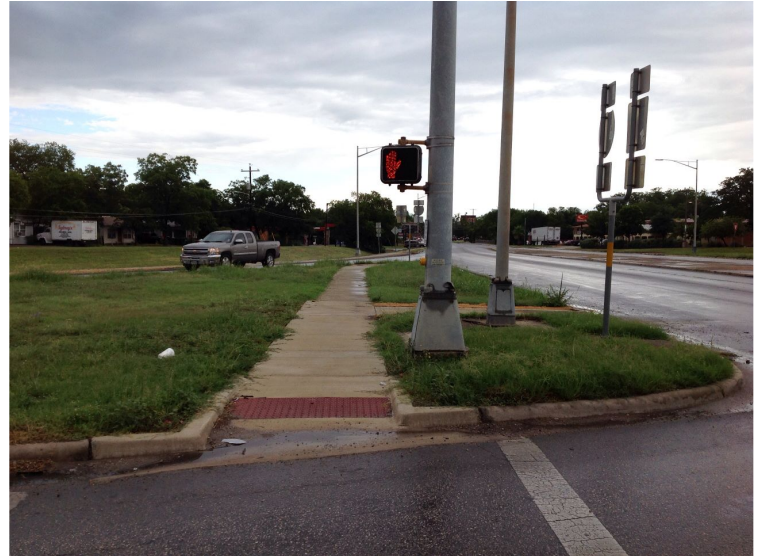
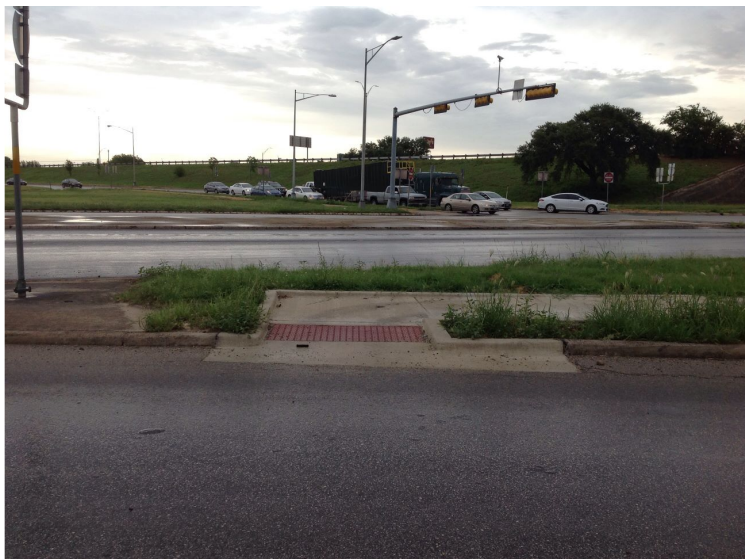
Location Photos

Ramp Elements	Curb ramp provided where an accessible route crosses a barrier:	YES
	Is the slope of the ramp 1:12 or less:	YES
	Transition from curb ramp slope to roadway free from abrupt changes, no greater than 1:20:	YES
	Ramp is at least 36" wide:	YES
	Ramp surface is stable, firm, and slip resistant:	YES
Flare	Flares (if present) are 1:10 or less measured along the curb line; or If landing at top of ramp is not provided flares are 1:12 or less:	N/A
Detectable Warning Surface	Curb ramp is located such that it does not project into roadway or parking aisles:	N/A
	Detectable warning is present:	YES
	DWS maintains correct geometric controls; 0.9" diameter domes, 0.2" in height, spaced at 2.35" and visually contracts adjacent ramp surface:	YES
Special Ramps	Ramp maintains defined edges parallel to direction of pedestrian travel; maintains 4'x4' turning pad contained in crosswalk; flared sides 24" segment on each side of ramp within crosswalk lines:	N/A

Ramp is located so they will not be obstructed by parked vehicles:	N/A
	Ramp wholly contained within the crosswalk lines:	YES
	If island is present; Island maintains a cut through at street level or ramps on either side with landing between them:	YES
