**CITY OF SAN MARCOS  
ADA TRANSITION PLAN  
SIGNALIZED INTERSECTION ASSESSMENT  
AND COMPLIANCE REPORT**

Location ID: 000000087  
 North-South Cross Street: IH 35 SBFR  
 East-West Cross Street: SH 123

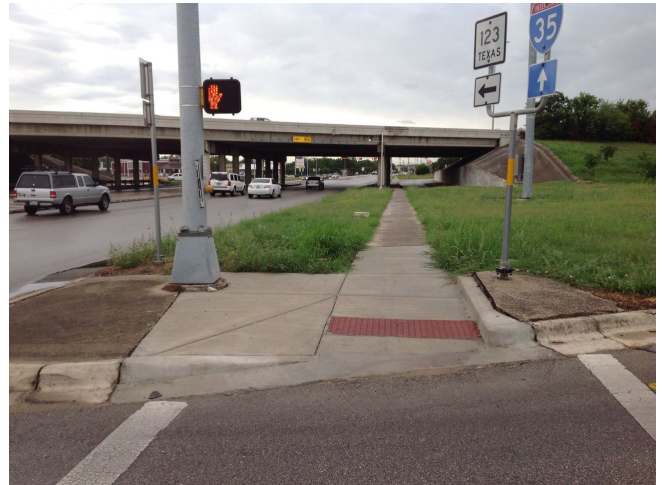
Signalized Intersection: YES  
 Accessible Features: YES  
 Pedestrian Features Accessible: YES

<b>Ramp Elements</b>	Curb ramp provided where an accessible route crosses a barrier:	YES
	Is the slope of the ramp 1:12 or less:	YES
	Transition from curb ramp slope to roadway free from abrupt changes, no greater than 1:20:	YES
	Ramp is at least 36" wide:	YES
	Ramp surface is stable, firm, and slip resistant:	YES
<b>Flare</b>	Flares (if present) are 1:10 or less measured along the curb line; or If landing at top of ramp is not provided flares are 1:12 or less:	YES
<b>Detectable Warning Surface</b>	Curb ramp is located such that it does not project into roadway or parking aisles:	N/A
	Detectable warning is present:	YES
	DWS maintains correct geometric controls; 0.9" diameter domes, 0.2" in height, spaced at 2.35" and visually contracts adjacent ramp surface:	YES
<b>Special Ramps</b>	Ramp maintains defined edges parallel to direction of pedestrian travel; maintains 4'x4' turning pad contained in crosswalk; flared sides 24" segment on each side of ramp within crosswalk lines:	N/A

Ramp is located so they will not be obstructed by parked vehicles:	N/A
	Ramp wholly contained within the crosswalk lines:	N/A
	If island is present; Island maintains a cut through at street level or ramps on either side with landing between them:	N/A
