CITY OF SAN MARCOS ADA TRANSITION PLAN SIGNALIZED INTERSECTION ASSESSMENT AND COMPLIANCE REPORT

Location ID: 0000000088
 North-South Cross Street: GUADALUPE ST
 East-West Cross Street: LOVE ST

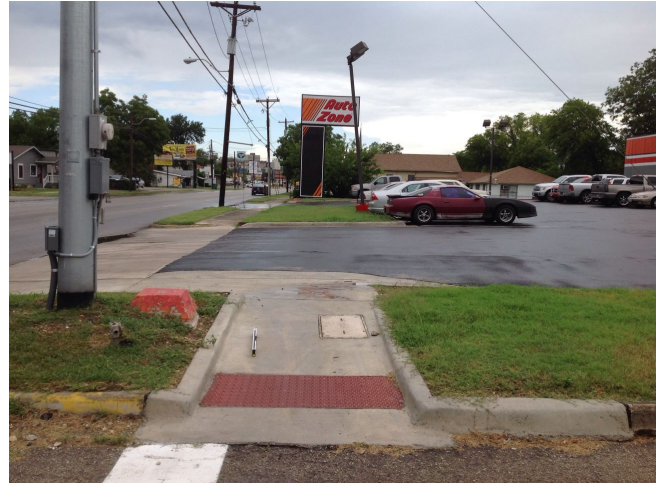
Signalized Intersection: YES
 Accessible Features: NO
 Pedestrian Features Accessible: NO

Ramp Elements	Curb ramp provided where an accessible route crosses a barrier:	YES
	Is the slope of the ramp 1:12 or less:	YES
	Transition from curb ramp slope to roadway free from abrupt changes, no greater than 1:20:	YES
	Ramp is at least 36" wide:	YES
	Ramp surface is stable, firm, and slip resistant:	YES
Flare	Flares (if present) are 1:10 or less measured along the curb line; or If landing at top of ramp is not provided flares are 1:12 or less:	N/A
Detectable Warning Surface	Curb ramp is located such that it does not project into roadway or parking aisles:	N/A
	Detectable warning is present:	YES
	DWS maintains correct geometric controls; 0.9" diameter domes, 0.2" in height, spaced at 2.35" and visually contracts adjacent ramp surface:	YES
Special Ramps	Ramp maintains defined edges parallel to direction of pedestrian travel; maintains 4'x4' turning pad contained in crosswalk; flared sides 24" segment on each side of ramp within crosswalk lines:	N/A

Ramp is located so they will not be obstructed by parked vehicles:	N/A
	Ramp wholly contained within the crosswalk lines:	N/A
	If island is present; Island maintains a cut through at street level or ramps on either side with landing between them:	N/A
