**CITY OF SAN MARCOS
ADA TRANSITION PLAN
SIGNALIZED INTERSECTION ASSESSMENT
AND COMPLIANCE REPORT**

Location ID: 0000000108
 North-South Cross Street: CRADDOCK AVE
 East-West Cross Street: RM 12

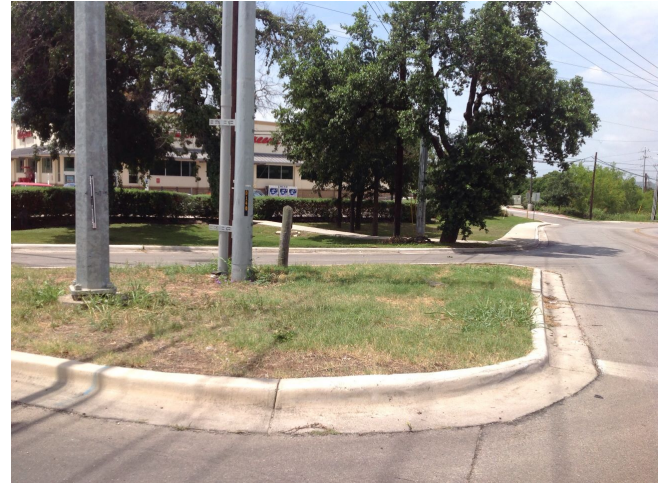
Signalized Intersection: YES
 Accessible Features: NO
 Pedestrian Features Accessible: NO

Ramp Elements	Curb ramp provided where an accessible route crosses a barrier:	NO
	Is the slope of the ramp 1:12 or less:	NO
	Transition from curb ramp slope to roadway free from abrupt changes, no greater than 1:20:	NO
	Ramp is at least 36" wide:	NO
	Ramp surface is stable, firm, and slip resistant:	NO
Flare	Flares (if present) are 1:10 or less measured along the curb line; or If landing at top of ramp is not provided flares are 1:12 or less:	NO
Detectable Warning Surface	Curb ramp is located such that it does not project into roadway or parking aisles:	N/A
	Detectable warning is present:	NO
	DWS maintains correct geometric controls; 0.9" diameter domes, 0.2" in height, spaced at 2.35" and visually contracts adjacent ramp surface:	NO
Special Ramps	Ramp maintains defined edges parallel to direction of pedestrian travel; maintains 4'x4' turning pad contained in crosswalk; flared sides 24" segment on each side of ramp within crosswalk lines:	N/A
