**CITY OF SAN MARCOS
ADA TRANSITION PLAN
SIGNALIZED INTERSECTION ASSESSMENT
AND COMPLIANCE REPORT**

Location ID: 0000000111
 North-South Cross Street: HOLLAND ST
 East-West Cross Street: RANCH ROAD 12

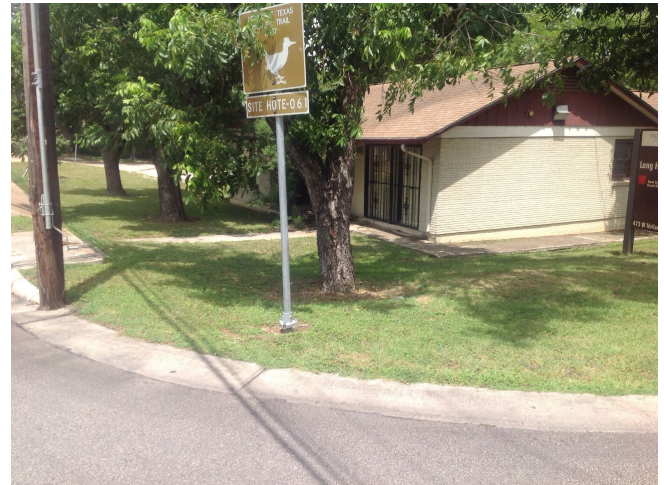
Signalized Intersection: YES
 Accessible Features: NO
 Pedestrian Features Accessible: NO

Ramp Elements	Curb ramp provided where an accessible route crosses a barrier:	NO
	Is the slope of the ramp 1:12 or less:	NO
	Transition from curb ramp slope to roadway free from abrupt changes, no greater than 1:20:	NO
	Ramp is at least 36" wide:	NO
	Ramp surface is stable, firm, and slip resistant:	NO
Flare	Flares (if present) are 1:10 or less measured along the curb line; or If landing at top of ramp is not provided flares are 1:12 or less:	NO
Detectable Warning Surface	Curb ramp is located such that it does not project into roadway or parking aisles:	N/A
	Detectable warning is present:	NO
	DWS maintains correct geometric controls; 0.9" diameter domes, 0.2" in height, spaced at 2.35" and visually contracts adjacent ramp surface:	NO
Special Ramps	Ramp maintains defined edges parallel to direction of pedestrian travel; maintains 4'x4' turning pad contained in crosswalk; flared sides 24" segment on each side of ramp within crosswalk lines:	N/A

Ramp is located so they will not be obstructed by parked vehicles:	N/A
	Ramp wholly contained within the crosswalk lines:	N/A
	If island is present; Island maintains a cut through at street level or ramps on either side with landing between them:	N/A
