CITY OF SAN MARCOS ADA TRANSITION PLAN SIGNALIZED INTERSECTION ASSESSMENT AND COMPLIANCE REPORT

Location ID: 0000000114
 North-South Cross Street: STUDENT CENTER DR
 East-West Cross Street: COMANCHE ST

North-South Cross Street: STUDENT CENTER DR

East-West Cross Street: COMANCHE ST

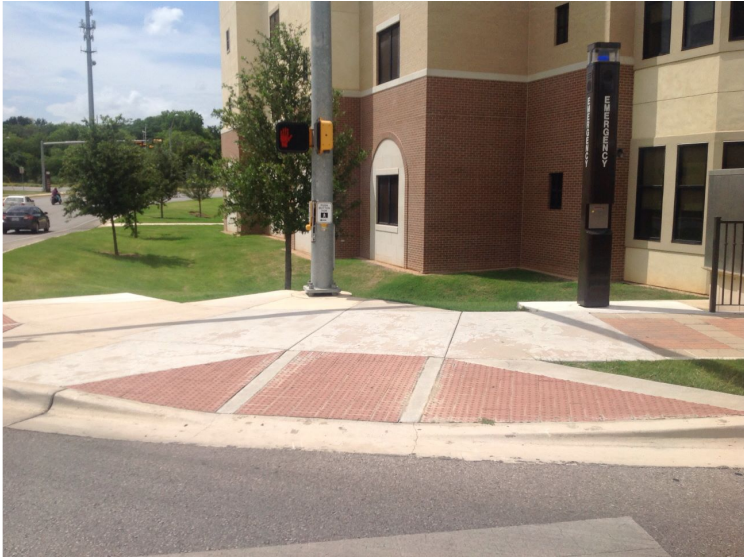
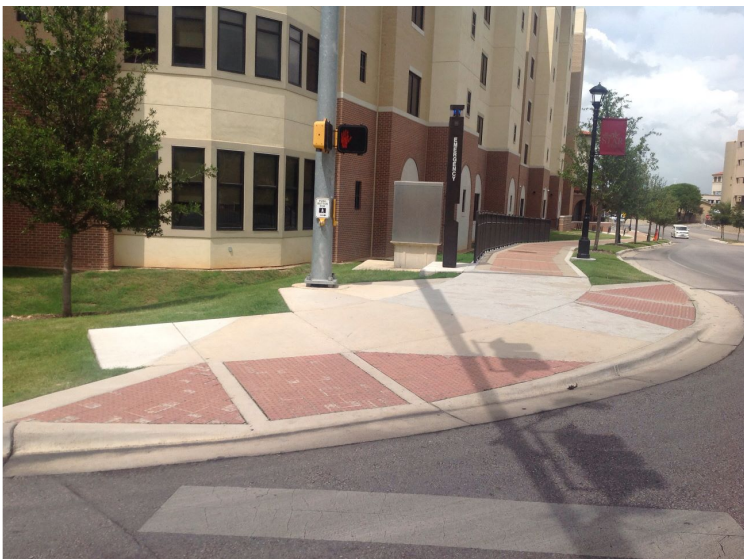
Location Photos

Ramp Elements	Curb ramp provided where an accessible route crosses a barrier:	YES
	Is the slope of the ramp 1:12 or less:	YES
	Transition from curb ramp slope to roadway free from abrupt changes, no greater than 1:20:	NO
	Ramp is at least 36" wide:	YES
	Ramp surface is stable, firm, and slip resistant:	YES
Flare	Flares (if present) are 1:10 or less measured along the curb line; or If landing at top of ramp is not provided flares are 1:12 or less:	YES
Detectable Warning Surface	Curb ramp is located such that it does not project into roadway or parking aisles:	N/A
	Detectable warning is present:	YES
	DWS maintains correct geometric controls; 0.9" diameter domes, 0.2" in height, spaced at 2.35" and visually contrasts adjacent ramp surface:	NO
Special Ramps	Ramp maintains defined edges parallel to direction of pedestrian travel; maintains 4'x4' turning pad contained in crosswalk; flared sides 24" segment on each side of ramp within crosswalk lines:	N/A
