# CITY OF SAN MARCOS ADA TRANSITION PLAN SIGNALIZED INTERSECTION ASSESSMENT AND COMPLIANCE REPORT

Location ID: 0000000115  
 North-South Cross Street: STUDENT CENTER DR  
 East-West Cross Street: COMANCHE ST

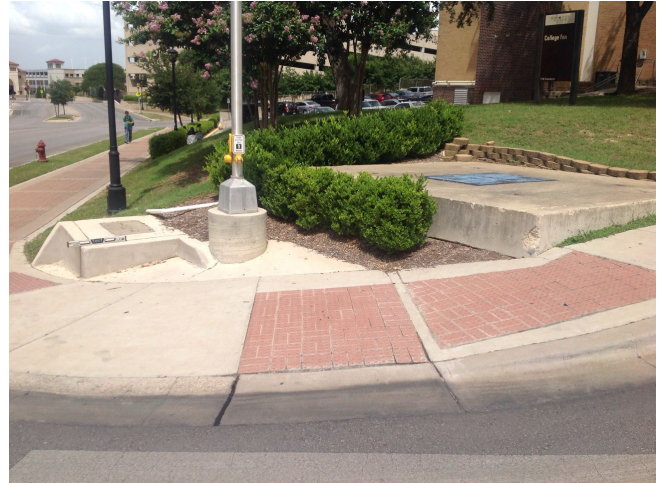
<b>Ramp Elements</b>	Curb ramp provided where an accessible route crosses a barrier:	YES
	Is the slope of the ramp 1:12 or less:	NO
	Transition from curb ramp slope to roadway free from abrupt changes, no greater than 1:20:	NO
	Ramp is at least 36" wide:	YES
	Ramp surface is stable, firm, and slip resistant:	YES
<b>Flare</b>	Flares (if present) are 1:10 or less measured along the curb line; or If landing at top of ramp is not provided flares are 1:12 or less:	NO
<b>Detectable Warning Surface</b>	Curb ramp is located such that it does not project into roadway or parking aisles:	N/A
	Detectable warning is present:	YES
	DWS maintains correct geometric controls; 0.9" diameter domes, 0.2" in height, spaced at 2.35" and visually contrasts adjacent ramp surface:	NO
<b>Special Ramps</b>	Ramp maintains defined edges parallel to direction of pedestrian travel; maintains 4'x4' turning pad contained in crosswalk; flared sides 24" segment on each side of ramp within crosswalk lines:	N/A

Ramp is located so they will not be obstructed by parked vehicles:	N/A
	Ramp wholly contained within the crosswalk lines:	YES
	If island is present; Island maintains a cut through at street level or ramps on either side with landing between them:	N/A
