**CITY OF SAN MARCOS
ADA TRANSITION PLAN
SIGNALIZED INTERSECTION ASSESSMENT
AND COMPLIANCE REPORT**

Location ID: 0000000118
 North-South Cross Street: HOPKINS ST
 East-West Cross Street: MOORE ST

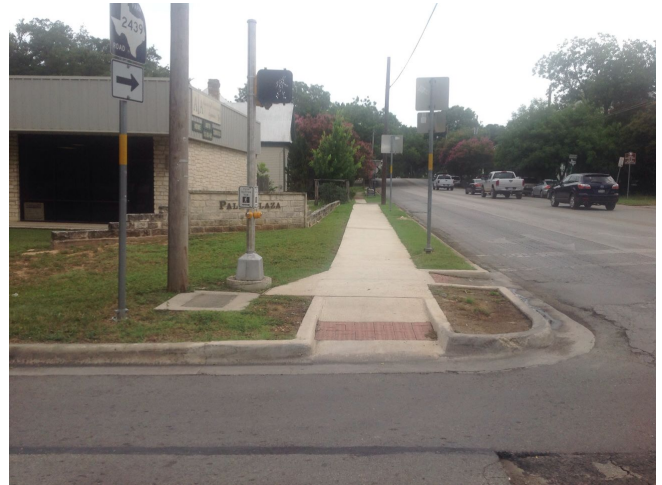
Signalized Intersection: YES
 Accessible Features: YES
 Pedestrian Features Accessible: YES

Ramp Elements	Curb ramp provided where an accessible route crosses a barrier:	YES
	Is the slope of the ramp 1:12 or less:	YES
	Transition from curb ramp slope to roadway free from abrupt changes, no greater than 1:20:	YES
	Ramp is at least 36" wide:	YES
	Ramp surface is stable, firm, and slip resistant:	YES
Flare	Flares (if present) are 1:10 or less measured along the curb line; or If landing at top of ramp is not provided flares are 1:12 or less:	N/A
Detectable Warning Surface	Curb ramp is located such that it does not project into roadway or parking aisles:	N/A
	Detectable warning is present:	YES
	DWS maintains correct geometric controls; 0.9" diameter domes, 0.2" in height, spaced at 2.35" and visually contrasts adjacent ramp surface:	YES
Special Ramps	Ramp maintains defined edges parallel to direction of pedestrian travel; maintains 4'x4' turning pad contained in crosswalk; flared sides 24" segment on each side of ramp within crosswalk lines:	N/A

Ramp is located so they will not be obstructed by parked vehicles:	N/A
	Ramp wholly contained within the crosswalk lines:	YES
	If island is present; Island maintains a cut through at street level or ramps on either side with landing between them:	N/A
