CITY OF SAN MARCOS ADA TRANSITION PLAN SIGNALIZED INTERSECTION ASSESSMENT AND COMPLIANCE REPORT

Location ID: 0000000125
 North-South Cross Street: UNIVERSITY DR
 East-West Cross Street: LBJ ST

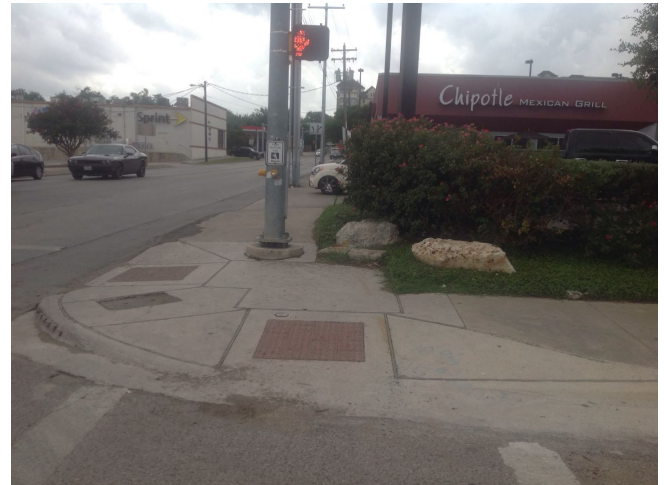
Signalized Intersection: YES
 Accessible Features: YES
 Pedestrian Features Accessible: YES

Ramp Elements	Curb ramp provided where an accessible route crosses a barrier:	NO
	Is the slope of the ramp 1:12 or less:	YES
	Transition from curb ramp slope to roadway free from abrupt changes, no greater than 1:20:	YES
	Ramp is at least 36" wide:	YES
	Ramp surface is stable, firm, and slip resistant:	YES
Flare	Flares (if present) are 1:10 or less measured along the curb line; or If landing at top of ramp is not provided flares are 1:12 or less:	YES
Detectable Warning Surface	Curb ramp is located such that it does not project into roadway or parking aisles:	NO
	Detectable warning is present:	NO
	DWS maintains correct geometric controls; 0.9" diameter domes, 0.2" in height, spaced at 2.35" and visually contracts adjacent ramp surface:	YES
Special Ramps	Ramp maintains defined edges parallel to direction of pedestrian travel; maintains 4'x4' turning pad contained in crosswalk; flared sides 24" segment on each side of ramp within crosswalk lines:	N/A

Ramp is located so they will not be obstructed by parked vehicles:	N/A
	Ramp wholly contained within the crosswalk lines:	YES
	If island is present; Island maintains a cut through at street level or ramps on either side with landing between them:	N/A
