CITY OF SAN MARCOS ADA TRANSITION PLAN SIGNALIZED INTERSECTION ASSESSMENT AND COMPLIANCE REPORT

Location ID: 0000000129
 North-South Cross Street: UNIVERSITY DR
 East-West Cross Street: EDWARD GRAY DR

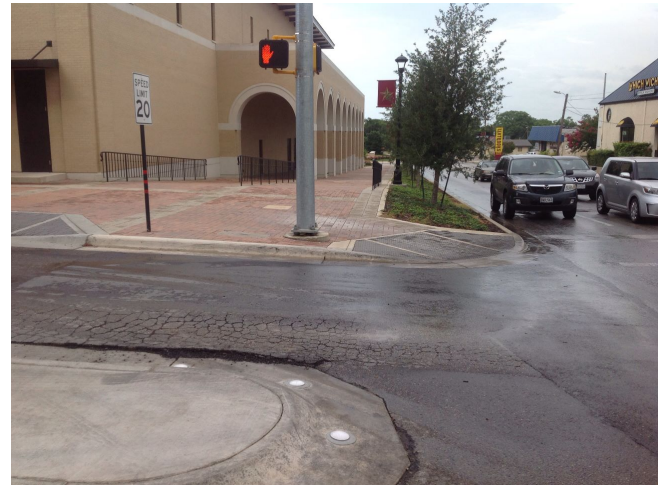
Signalized Intersection: YES
 Accessible Features: NO
 Pedestrian Features Accessible: NO

Ramp Elements	Curb ramp provided where an accessible route crosses a barrier:	YES
	Is the slope of the ramp 1:12 or less:	YES
	Transition from curb ramp slope to roadway free from abrupt changes, no greater than 1:20:	YES
	Ramp is at least 36" wide:	YES
	Ramp surface is stable, firm, and slip resistant:	YES
Flare	Flares (if present) are 1:10 or less measured along the curb line; or If landing at top of ramp is not provided flares are 1:12 or less:	NO
Detectable Warning Surface	Curb ramp is located such that it does not project into roadway or parking aisles:	N/A
	Detectable warning is present:	YES
	DWS maintains correct geometric controls; 0.9" diameter domes, 0.2" in height, spaced at 2.35" and visually contracts adjacent ramp surface:	NO
Special Ramps	Ramp maintains defined edges parallel to direction of pedestrian travel; maintains 4'x4' turning pad contained in crosswalk; flared sides 24" segment on each side of ramp within crosswalk lines:	NO

Ramp is located so they will not be obstructed by parked vehicles:	N/A
	Ramp wholly contained within the crosswalk lines:	YES
	If island is present; Island maintains a cut through at street level or ramps on either side with landing between them:	N/A
