**CITY OF SAN MARCOS
ADA TRANSITION PLAN
SIGNALIZED INTERSECTION ASSESSMENT
AND COMPLIANCE REPORT**

Location ID: 0000000130
 North-South Cross Street: HOPKINS ST
 East-West Cross Street: EDWARD GARY ST

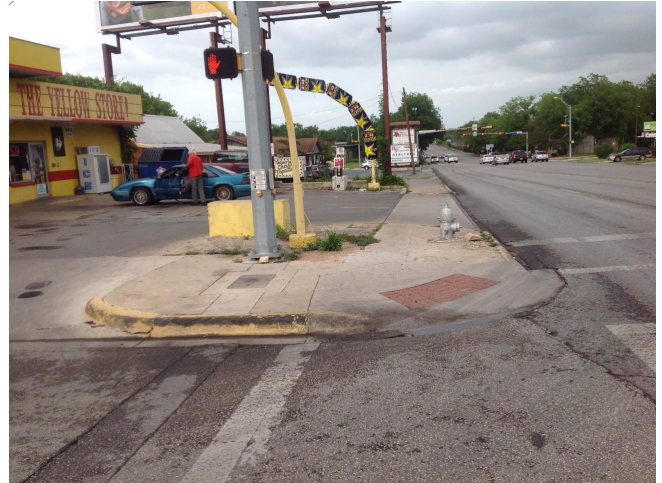
Signalized Intersection: YES
 Accessible Features: YES
 Pedestrian Features Accessible: YES

Ramp Elements	Curb ramp provided where an accessible route crosses a barrier:	YES
	Is the slope of the ramp 1:12 or less:	YES
	Transition from curb ramp slope to roadway free from abrupt changes, no greater than 1:20:	NO
	Ramp is at least 36" wide:	YES
	Ramp surface is stable, firm, and slip resistant:	YES
Flare	Flares (if present) are 1:10 or less measured along the curb line; or If landing at top of ramp is not provided flares are 1:12 or less:	NO
Detectable Warning Surface	Curb ramp is located such that it does not project into roadway or parking aisles:	NO
	Detectable warning is present:	YES
	DWS maintains correct geometric controls; 0.9" diameter domes, 0.2" in height, spaced at 2.35" and visually contracts adjacent ramp surface:	YES
Special Ramps	Ramp maintains defined edges parallel to direction of pedestrian travel; maintains 4'x4' turning pad contained in crosswalk; flared sides 24" segment on each side of ramp within crosswalk lines:	NO

Ramp is located so they will not be obstructed by parked vehicles:	N/A
	Ramp wholly contained within the crosswalk lines:	YES
	If island is present; Island maintains a cut through at street level or ramps on either side with landing between them:	N/A
