CITY OF SAN MARCOS ADA TRANSITION PLAN SIGNALIZED INTERSECTION ASSESSMENT AND COMPLIANCE REPORT

Location ID: 0000000131
 North-South Cross Street: HOPKINS ST
 East-West Cross Street: EDWARD GARY ST

Location ID: 0000000131

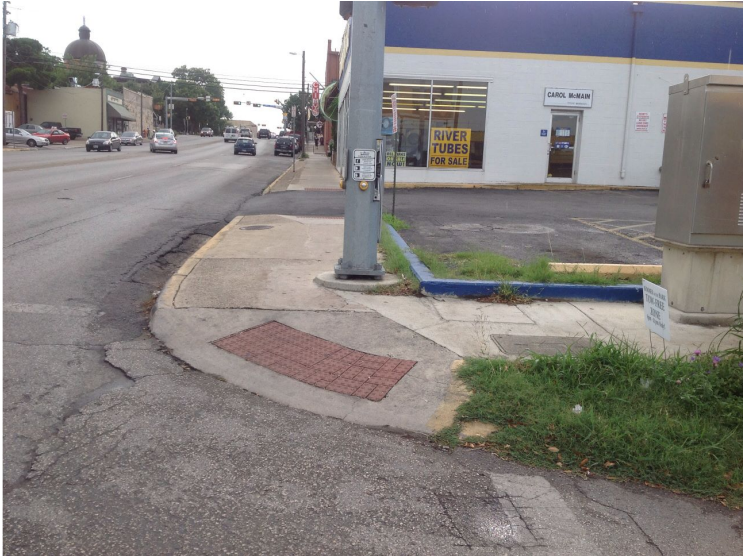
Location Photos

Ramp Elements	Curb ramp provided where an accessible route crosses a barrier:	YES
	Is the slope of the ramp 1:12 or less:	NO
	Transition from curb ramp slope to roadway free from abrupt changes, no greater than 1:20:	NO
	Ramp is at least 36" wide:	YES
	Ramp surface is stable, firm, and slip resistant:	YES
Flare	Flares (if present) are 1:10 or less measured along the curb line; or If landing at top of ramp is not provided flares are 1:12 or less:	NO
Detectable Warning Surface	Curb ramp is located such that it does not project into roadway or parking aisles:	
	Detectable warning is present:	YES
	DWS maintains correct geometric controls; 0.9" diameter domes, 0.2" in height, spaced at 2.35" and visually contrasts adjacent ramp surface:	YES
Special Ramps	Ramp maintains defined edges parallel to direction of pedestrian travel; maintains 4'x4' turning pad contained in crosswalk; flared sides 24" segment on each side of ramp within crosswalk lines:	YES
