CITY OF SAN MARCOS ADA TRANSITION PLAN SIGNALIZED INTERSECTION ASSESSMENT AND COMPLIANCE REPORT

Location ID: 0000000132
 North-South Cross Street: HOPKINS ST
 East-West Cross Street: C M ALLEN PKWY

Location ID: 0000000132

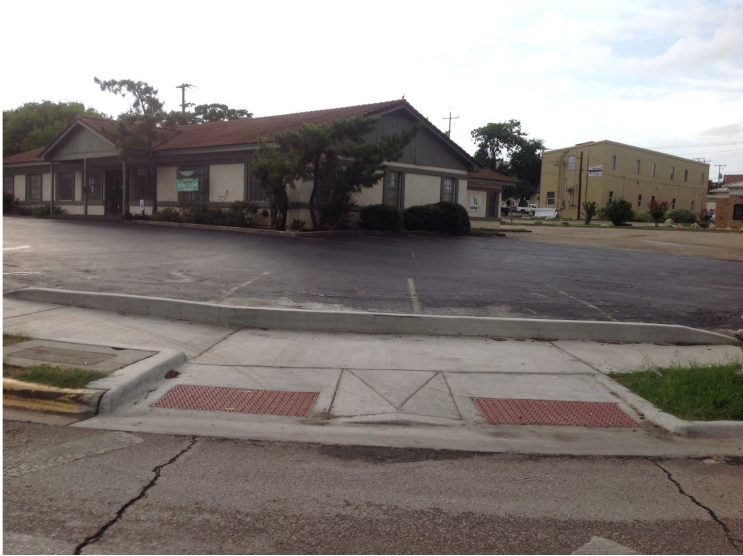
Location Photos

Ramp is located so they will not be obstructed by parked vehicles:	N/A
	Ramp wholly contained within the crosswalk lines:	NO
	If island is present; Island maintains a cut through at street level or ramps on either side with landing between them:	N/A
