CITY OF SAN MARCOS ADA TRANSITION PLAN SIGNALIZED INTERSECTION ASSESSMENT AND COMPLIANCE REPORT

Location ID: 0000000134
 North-South Cross Street: HOPKINS ST
 East-West Cross Street: LYNDON B JOHNSON DR

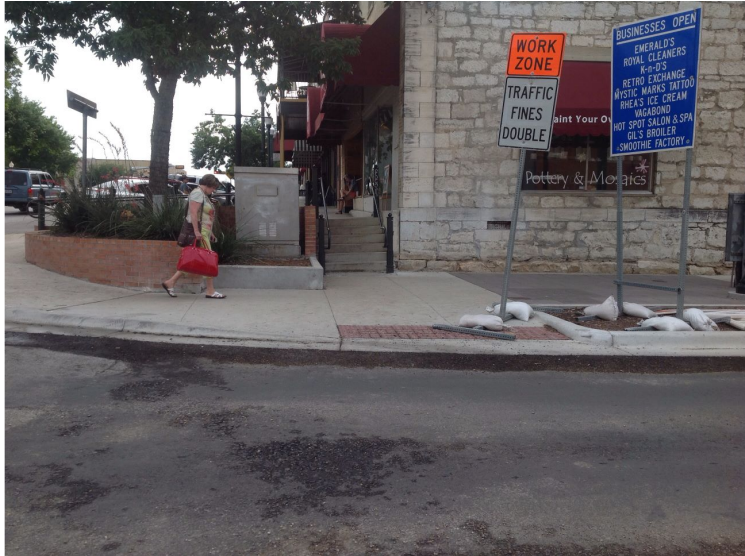
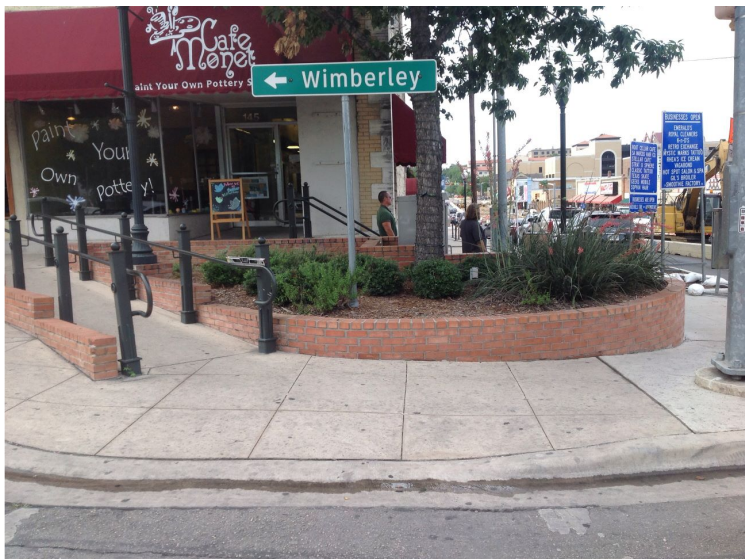
Location Photos

Ramp Elements	Curb ramp provided where an accessible route crosses a barrier:	YES
	Is the slope of the ramp 1:12 or less:	YES
	Transition from curb ramp slope to roadway free from abrupt changes, no greater than 1:20:	NO
	Ramp is at least 36" wide:	YES
	Ramp surface is stable, firm, and slip resistant:	YES
Flare	Flares (if present) are 1:10 or less measured along the curb line; or If landing at top of ramp is not provided flares are 1:12 or less:	N/A
Detectable Warning Surface	Curb ramp is located such that it does not project into roadway or parking aisles:	N/A
	Detectable warning is present:	NO
	DWS maintains correct geometric controls; 0.9" diameter domes, 0.2" in height, spaced at 2.35" and visually contrasts adjacent ramp surface:	YES
Special Ramps	Ramp maintains defined edges parallel to direction of pedestrian travel; maintains 4'x4' turning pad contained in crosswalk; flared sides 24" segment on each side of ramp within crosswalk lines:	N/A
